CULVERT REPAIR PREVENTS POTENTIAL ROAD COLLAPSE

BARCELONA, SPAIN

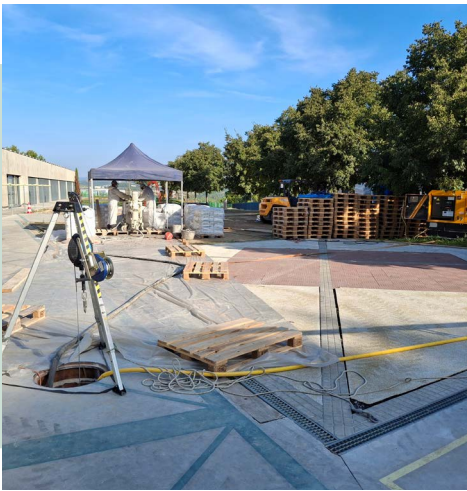
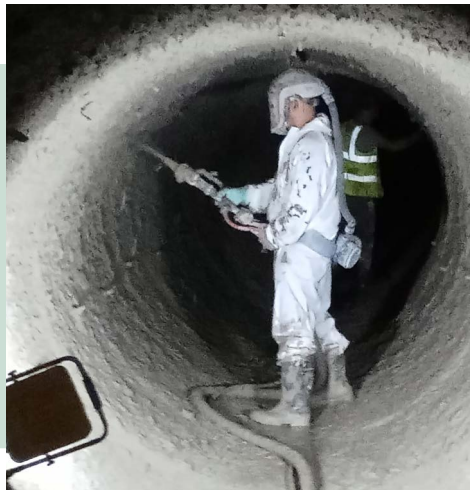
A segmented concrete pipe culvert beneath a busy street in Barcelona, Spain, had settled over time, leading to leaking joints and erosion. The damage was beginning to buckle the roadway—posing a serious risk of collapse or sinkhole formation.

To solve the problem efficiently and safely, the project team turned to LOCTITE GeoSpray HCE which was capable of providing a fully structural repair. The material could be pumped up to 150 meters and hand-sprayed inside the two-meter-diameter culvert, allowing crews to restore the pipe from within. Over ten days, a 73-millimeter-thick layer was applied along the full length of the culvert, reinforcing it to meet modern structural standards.

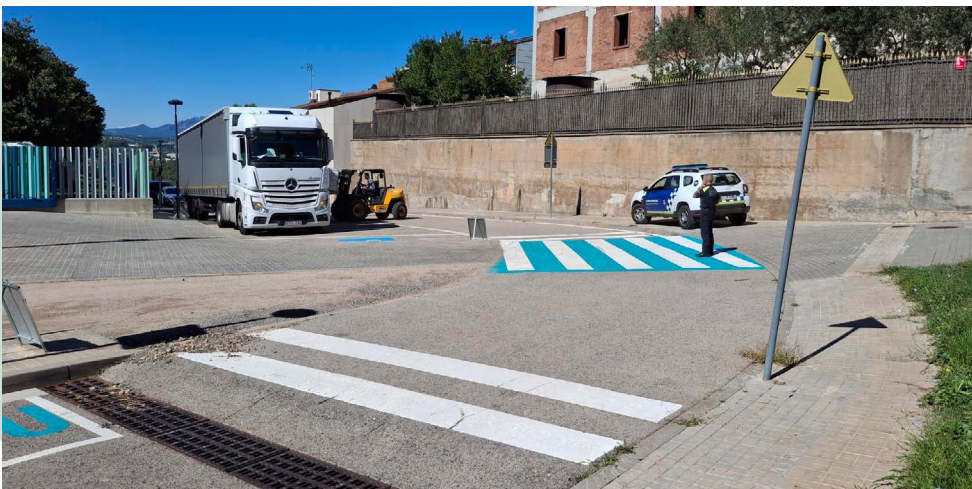
In the end, the culvert was fully rehabilitated and now boasts a 50-year design life and renewed structural integrity.
