BlackDiamond® 12" Lamination Repair on Liquids Pipeline in USA

Pipe Details

- Customer: Liquid transmission pipeline operator
- Pipe Diameter: 12"
- Design Pressure: 1440 psi MAOP
- Pipe Contents: Refined products
- Pipe Defect: Lamination defect in the seam weld

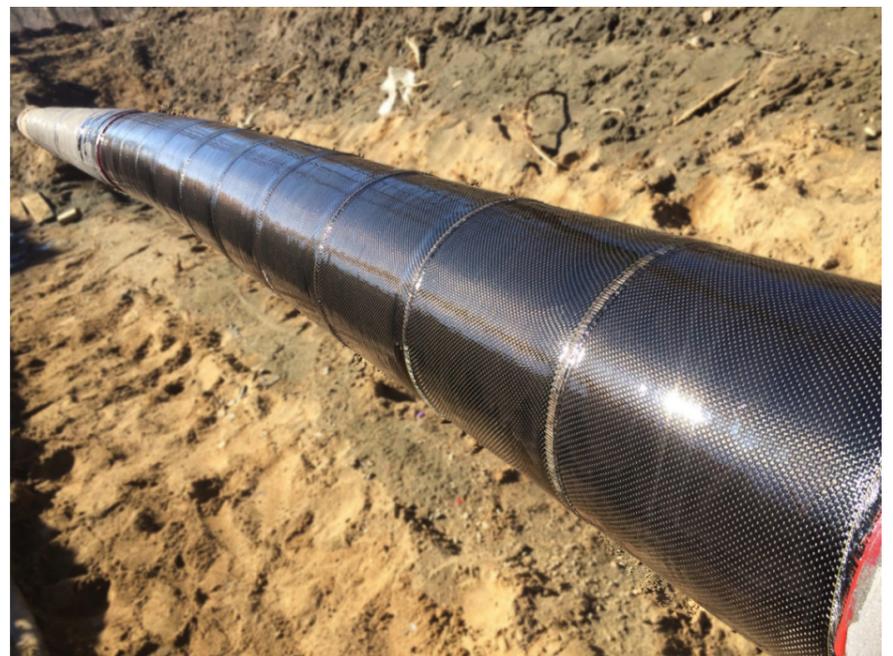
CSNRI mobilized a trainer within a couple days to train and certify several of the pipeline operators' employees. Once trained and certified, the installers applied 6 layers of carbon fiber over a 21-foot repair length, according to the calculations prepared by the CSNRI engineer. The actual installation time was less than half a day, and the pipeline operator was able to backfill the dig in the same day. No heavy equipment or hotwork was required for the installation, and the line was in operation throughout all rehabilitation activities. Below is a photo of the completed repair.

CSNRI's team of engineers designed a permanent repair for the defect according to ASME PCC-2 Article 4.1, and recommended a BlackDiamond® repair solution. 6 layers of BlackDiamond® were required to repair the defect, even with the high design pressure.
