Composite Repair Addresses Galvanic Corrosion

West Africa

Pipe Details

- 457-mm (18-inch) crude processing lines
- 20 bar (290 psi) operating pressure
- Ambient temperature

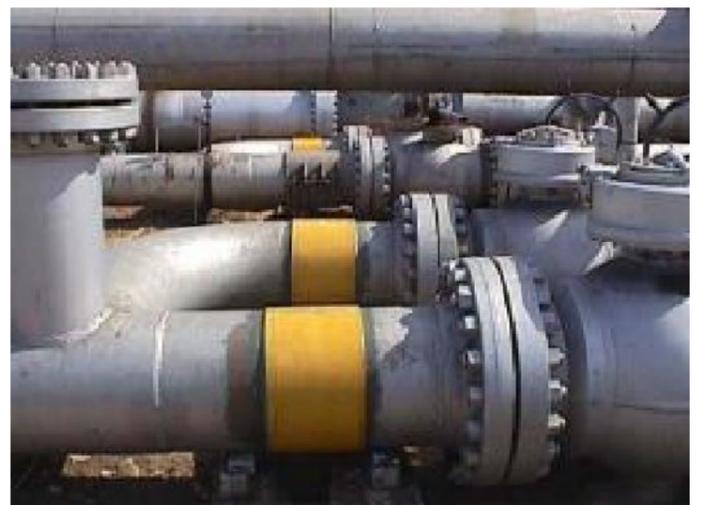
During an inspection of its outdoor crude processing piping, a company found evidence of external corrosion on several of its 457-mm (18-inch) lines operating under 20 bar (290 psi) pressure. The cause of the corrosion was a combination of water entrapment and galvanic corrosion, also known as bimetallic corrosion, which is the result of an electrochemical process in which one metal corrodes when it is in electrical contact with another in the presence of an electrolyte. Under these circumstances, corrosion occurs in one of the metals much more rapidly than it does in the other.

18" pipe support repairs

Because of the position of the pipes, it was not possible to raise them to carry out the repair. To access the affected areas of the lines, the Clock Spring trained repair team inserted blocks to support the pipe, cutting away and removing the original pipe supports. To ready the pipe for the application of the Clock Spring repair, the team used wire brushes and sandpaper to prepare the pipe by hand.

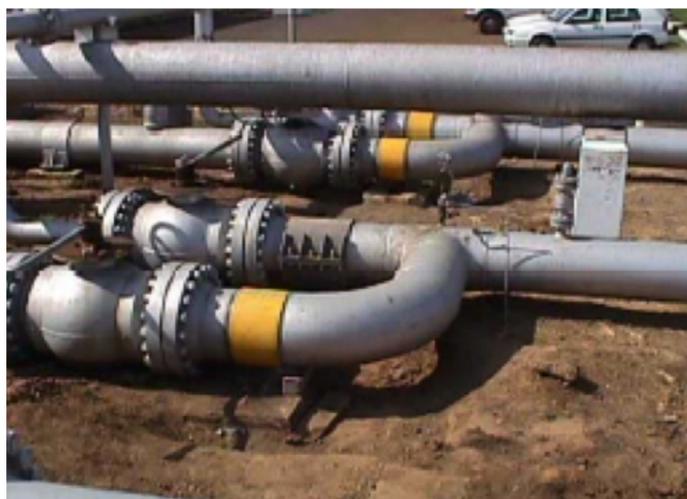
From preparation to final testing, the installation team was able to complete 3 repairs in 2 hours, including replacing old pipe supports with new ones and removing the old blocks.
