Composite Repairs Internal Corrosion on Cooling Water Line

Poland

Pipe Details

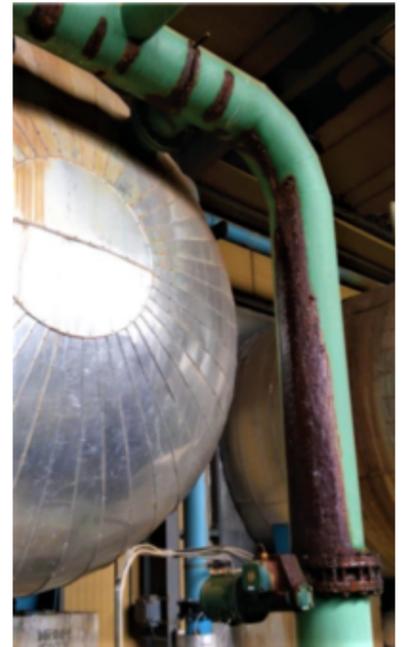
Internal corrosion on a 16-inch (mm) cooling water line in a fertilizer plant led to a leak in the aging system. Corrosion had affected a 40-inch (101 cm) section, and the line needed immediate attention.

Damaged Cooling Water Line

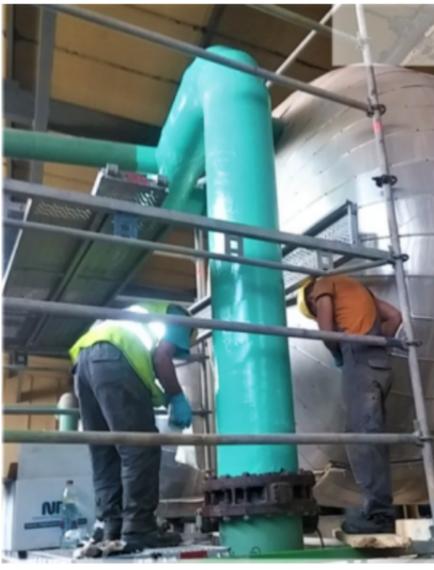
Cooling Water Line Repair

Technicians began the installation by preparing the surface of the damaged cooling line and used Syntho-Steel putty filler to fill the voids and restore the pipe's original geometry, then the entire defective spool was coated with 30 mils of Syntho-SubSea LV, an anti-corrosion primer that promotes adhesion of the composite to the surface of the pipe. The coating was followed by 12 layers of Syntho-Glass XT, which technicians wrapped around the straight line, elbow, and 3 tee joints.
