# Contour Restores High-Temperature Caustic Line

Jubail, Saudi Arabia

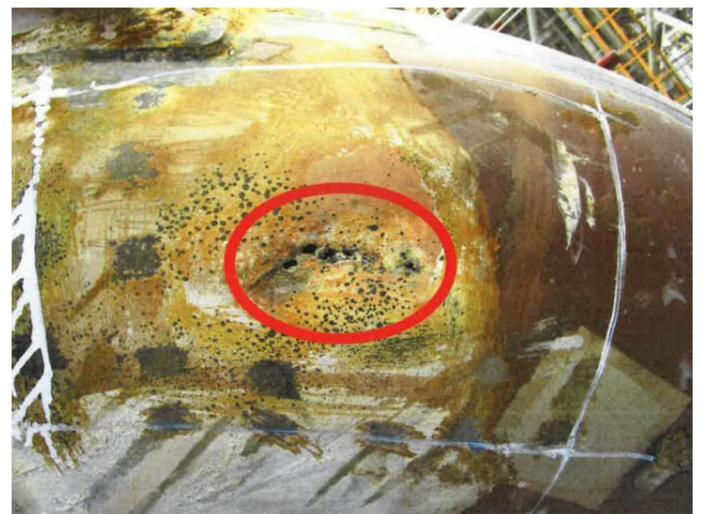
Inspections at a chemical plant revealed internal corrosion damage to a caustic evaporation unit operating under 1 bar (14.5 psi) at 115° C (239° F). The 610-mm (24-inch) line had sustained corrosion at the first elbow of the duct, resulting in a 152.4-mm x 203.2-mm (6-inch x 8-inch) defect area. Wall thinning had taken place over the entire elbow, and there was insulation damage on the equipment and piping under the leaking area.

*Inspections at a chemical plant revealed internal corrosion damage to a caustic evaporation unit.*

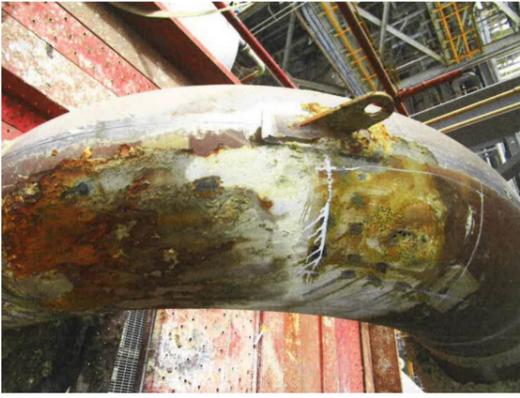
*Wall thinning had taken place over the entire elbow*

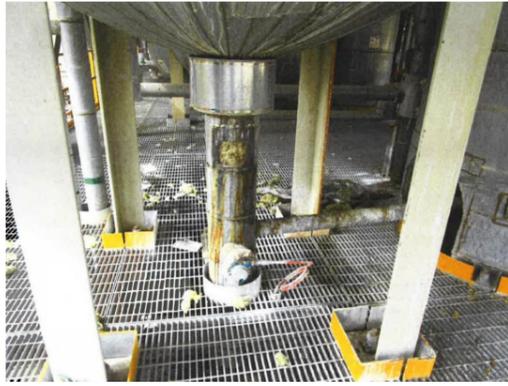
*Leaking caustic from the damaged elbow caused insulation damage on the equipment and piping underneath.*

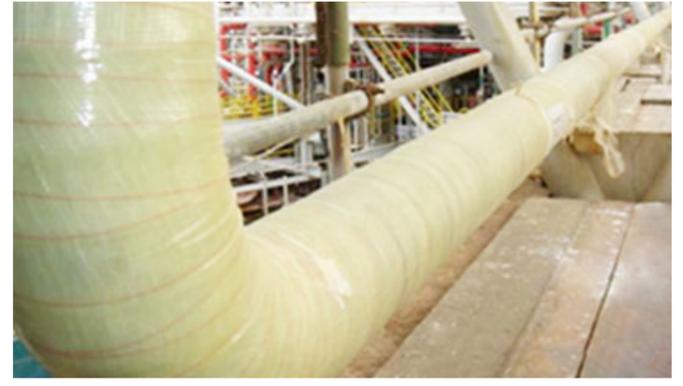
*A team of 5 technicians reinforced the damaged area with Contour, completing the entire repair in 2 days, restoring line integrity and enabling safe operations.*

The solution incorporated Contour, an engineered wet-applied repair system that uses quad-axial stitched fiberglass cloth applied with two-part epoxy and a filler material. Contour is ideal for repairs like this one because it is designed for a range of defects, including leaks, and can be applied easily to bends and complex geometry. It is regularly used in plants, refineries, tank farms, terminals, and offshore locations to repair a variety of pipe defects.

The Contour repair was designed for a 2-year lifetime based on a design temperature of 115° C (239° F), and a design pressure of 5 bar (72.5 psi). Since the caustic vapor line typically operates at vacuum pressure, the repair took into account vacuum loading of up to 1 bar (14.5 psi). The repair size would allow the area with the leaks to be restored to safety and extended an additional 19 inches (480 mm) beyond the damaged area. A taper of 105 mm (4 inches) was applied at the edge of the repair to limit movement of the substrate and help with load transfer. The proposed finished repair was 21 mm (0.83 inch) thick and consisted of 10 layers of Contour quad-axial fiberglass impregnated with high-temperature epoxy resin.

A team of 5 trained and certified technicians prepared the pipe surface and reinforced the damaged area with Contour, completing the entire repair in 2 days to deliver a safe and reliable solution that eliminated the threat to the environment and restored line integrity, allowing safe operations.
