# Leak Stopper, DiamondWrap® Restore Leaking Pipe to Safe Service

### Pipe Details

- A 12-inch (305-mm) carbon steel pipe transporting harsh chemicals suffered a pinhole leak caused by internal corrosion
- 43° C (109.4° F) Operating Temperature
- 148 C (298.4° F) Design Temperature
- -5° C (23° F) Ambient Temperature During Installation

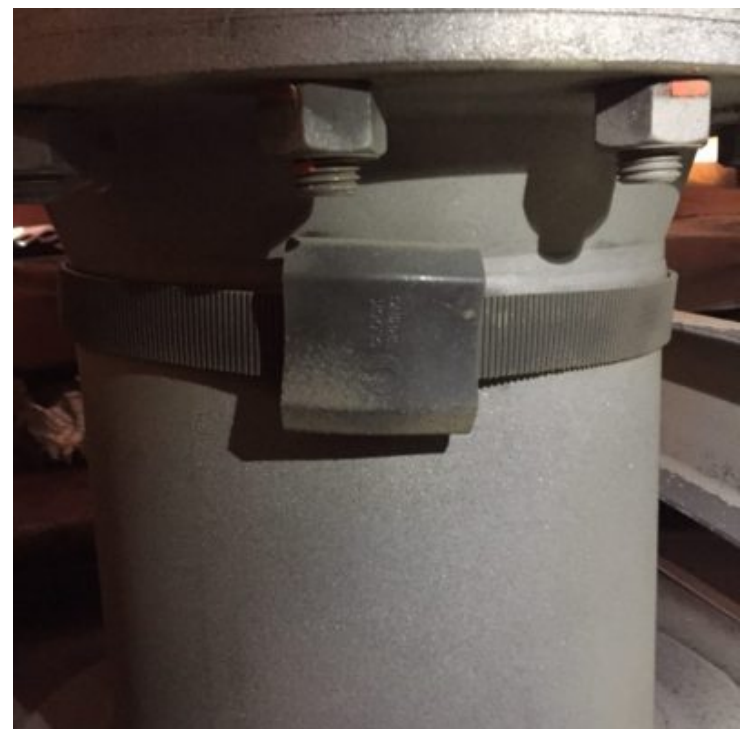
*Leak Stopper Applied*

A team of 2 trained and certified installers secured the band of the Leak Stopper on the pipe to cover the leak and used a ratchet to tighten the band until the leak was stopped, stopping the leak within less than a minute. Using the back of the tightening tool to trim the excess slack from the band, the team created a repair with a finished profile that is only 1 inch (25.4 mm) wide that was ready to be overwrapped with the DiamondWrap® for a lasting repair.

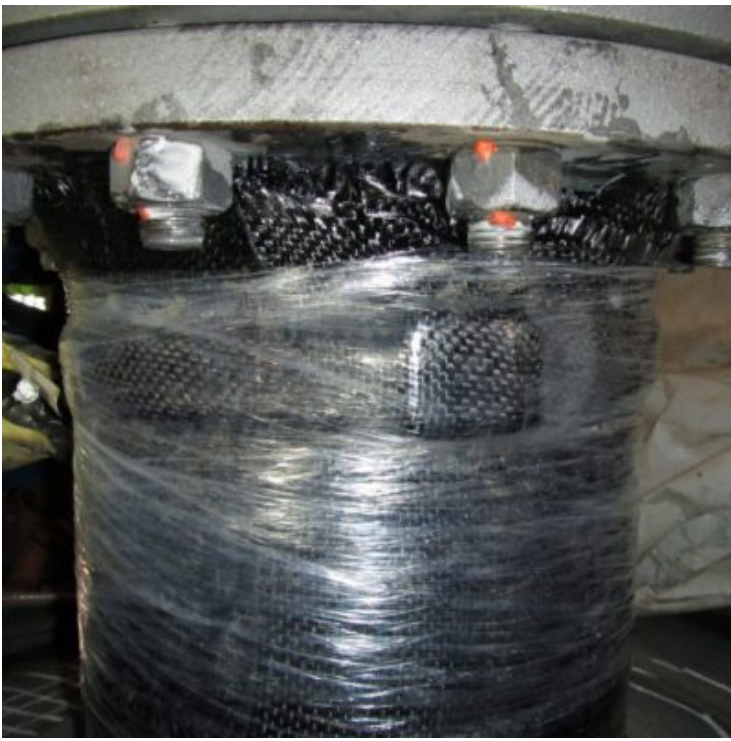
*LeakStopper Overwrapped with DiamondWrap*

With the leak safely arrested, the installers proceeded with the application of four layers of axial strips of carbon fiber over a length of 18 inches (46 cm) to repair the nozzle and achieve the final design, restoring safety within 1 hour without requiring the line to be shut in.
