Scar-Guard Protects Field Joint Coating During HDD

Pipe Details

Summary

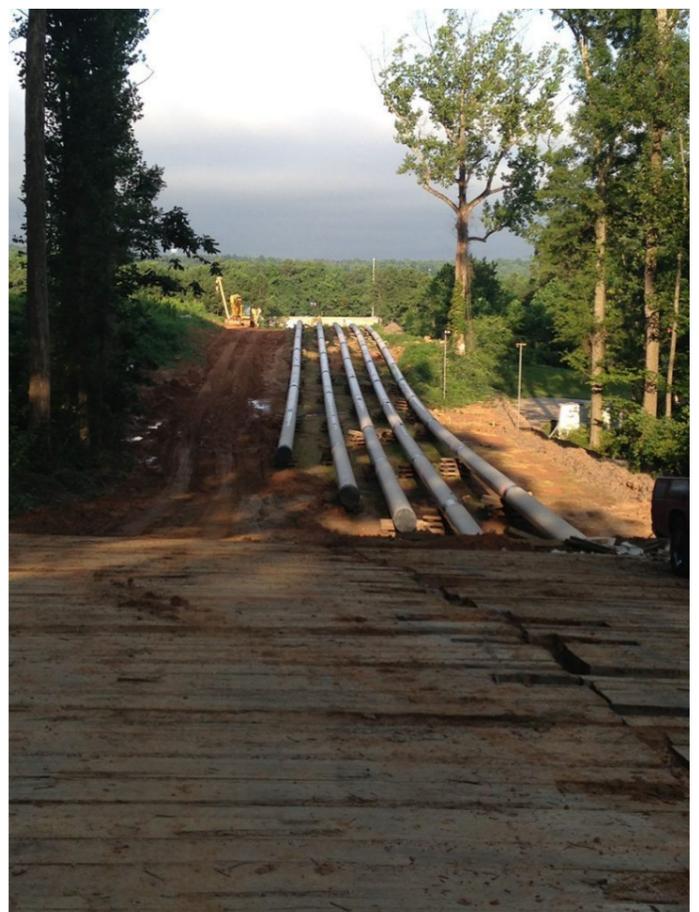
A natural gas utility company was installing a new, 24-inch (609.6-mm) steel pipeline through granite via horizontal directional drilling (HDD).

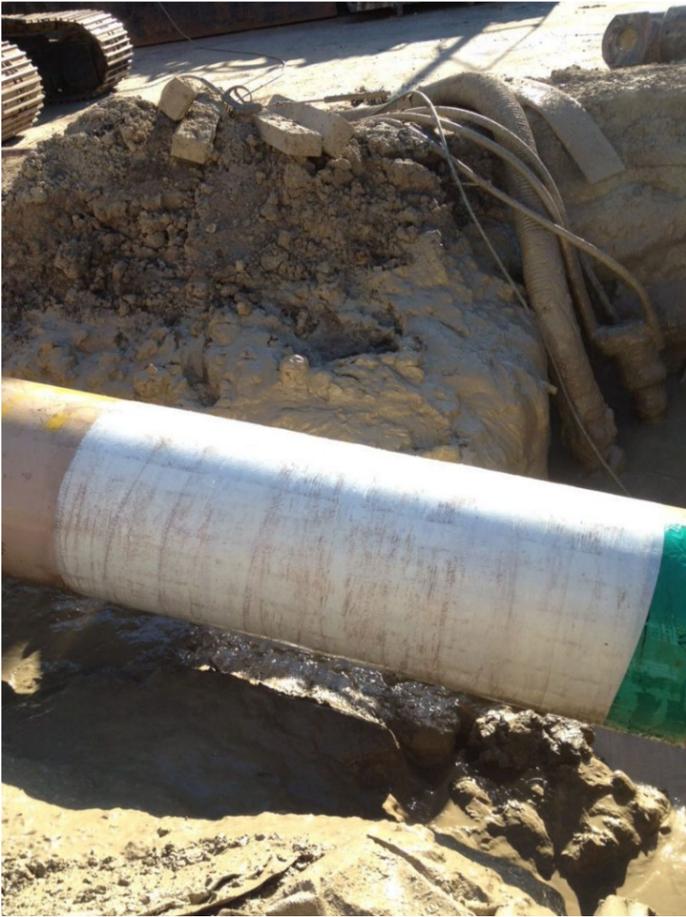
To test this ARO, technicians welded a length of pipe to the line and applied four layers of Scar-Guard over the first field joint 40 ft (12 m) behind the bore head as a sacrificial, mechanically protective coating. The location was specifically chosen to ensure that the composite reinforced coating would be exposed to the brunt of

all forces to which this pipeline would be subjected. Due to the relatively large application area, which covered 5 ft (1.5 m), ClockSpring|NRI engineers selected a relatively slow-curing resin to allow sufficient working time.

With the Scar-Guard system applied, the pilot section of pipe was installed following the same methodology that would be used for the pipeline. After the line was installed, it was pulled back and examined for damage. Although there were some areas of the sacrificial composite reinforced coating that experienced abrasion, there was no damage to the corrosion coating protecting the pipeline. A close inspection by the coating inspector, utility engineer, and contractor's superintendent revealed that Scar-Guard provided the necessary protection to ensure a successful job.

After the line was installed with Scar-Guard applied, it was pulled back and examined for damage.

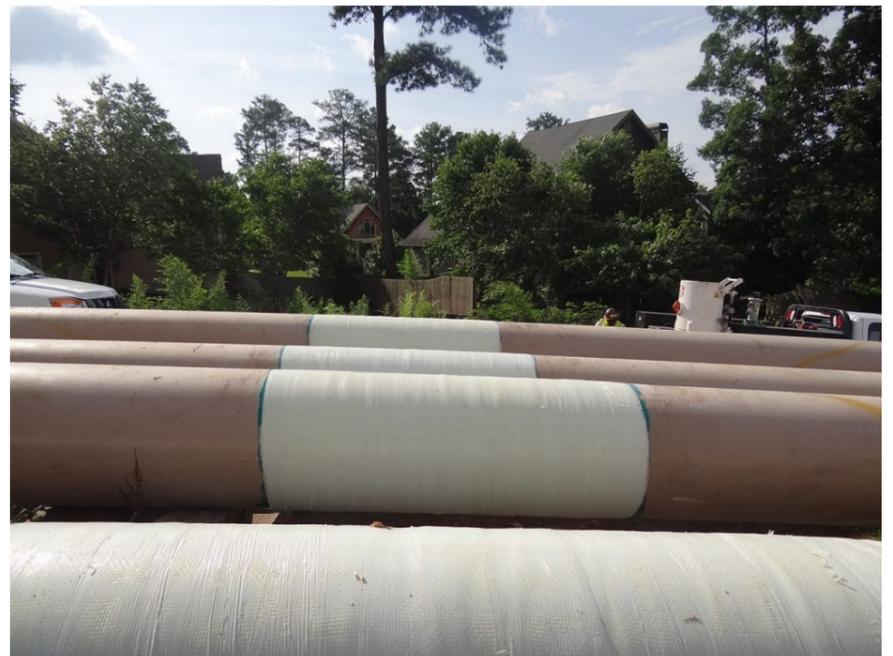
Scar-Guard provides added security in high-consequence areas to ensure the pipeline coating remains intact.
