# Snap Wrap Repair Halts Refinery Line Leak

### Pipe Details

- 8-inch (200-mm) diameter stainless steel line
- 50 psi (3.4 bar)
- 100° F (38° C) operating temperature

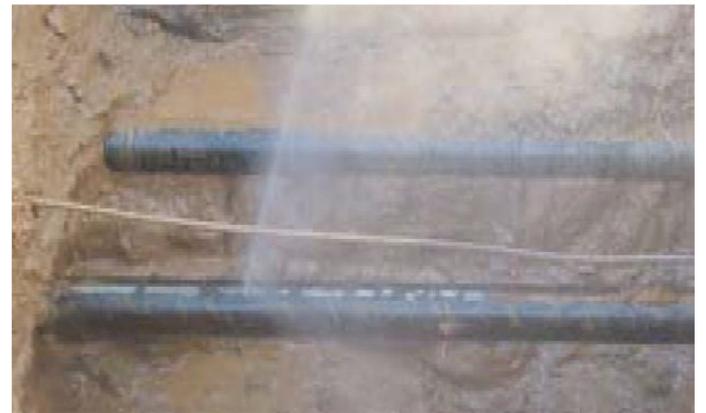
When inspections at a US refinery identified a line leak in an 8-inch (200-mm) diameter stainless steel line, the company immediately moved to correct the problem. Multiple pinhole leaks had formed over a 35-foot (1-m) section of a pipe that was being used to transport a corrosive product (82% nitrogen, 6.5% acetic acid, 1.9% water, 8.3% oxygen, 1% hydrogen bromide, 0.2% methyl acetate, 0.1% methanol). The line was under 50 psi (3.4 bar) pressure in a 100° F (38° C) operating environment.

*The leaking and failed pipeline*

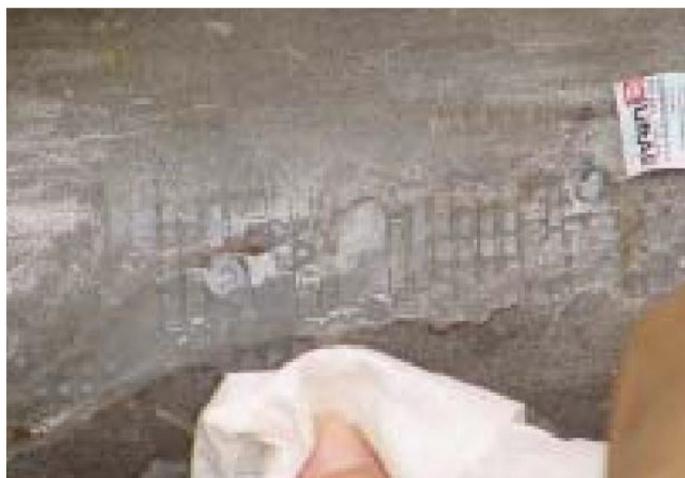
*Application of the nylon plugs into the drilled holes*

The first step was to drill each pinhole leak to the appropriate diameter to accommodate a nylon plug, which was manually inserted in each hole to stop the leaks. Once the line was plugged, the external surface of the pipe was cleaned by hand, and a leak stop was applied. Then, the technician installed Clock Spring Snap Wraps over the complete 35-foot (11-m) section of pipe.

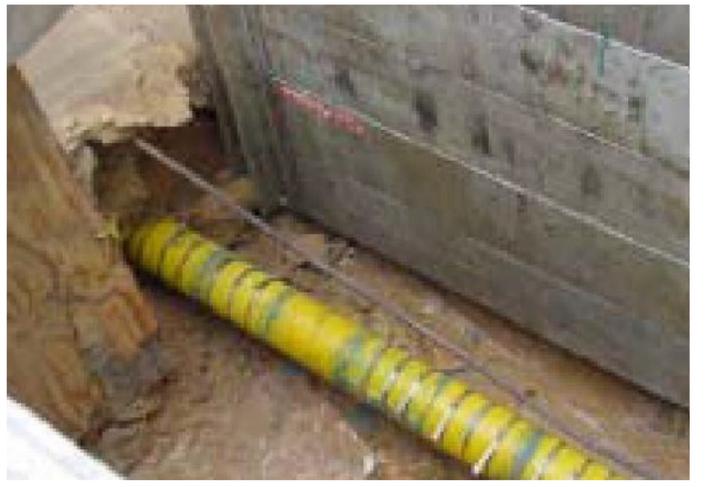
*Completed Snap Wrap installation*

A single technician completed the installation in less than 2 days, creating little disruption to the day-to-day activities in the refinery and allowing the company to continue working while the critical repair was taking place.
