Offshore[®]

Composites improving corrosion mitigation on offshore assets

System deployed in the Gulf of Mexico

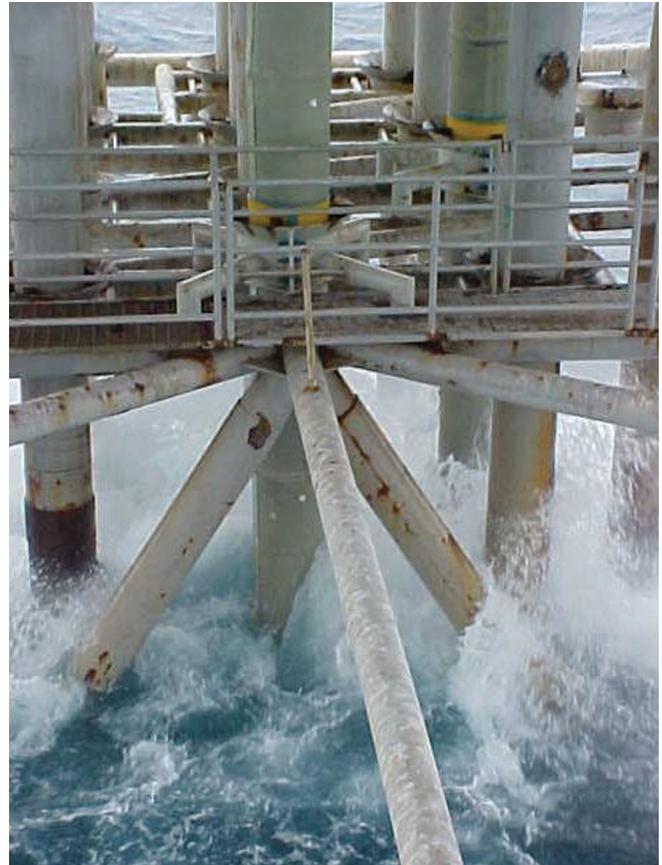
With the broad range of composite repair systems available, there is a proven solution for nearly every type of corrosion found offshore. (All images courtesy CSNRI)

Composite technology has been used for decades to safely protect or rehabilitate steel. It has proven to be robust and long-lasting in a range of applications. Composites are 10-30 times stronger than liquid epoxies and have approximately 10 times greater fracture toughness. With the broad range of engineered composite repair (ECR) systems available, there is a proven solution for nearly every type of corrosion found offshore.

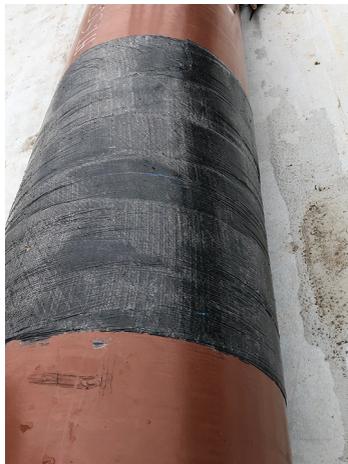
Scar-Guard was developed specifically to protect field joint and mainline coatings from mechanical stresses and scarring.

This sacrificial outer laminate system protects pre-approved anti-corrosion coatings, such as fusion bonded epoxy, liquid epoxies, shrink sleeves, and tapes, providing robust protection of the underlying pipeline coating. It ensures pipeline integrity and prevents future external corrosion without introducing environmental hazards. Because this composite is delivered in rolls, it is easy to transport to the worksite and can be installed without special tools and equipment.

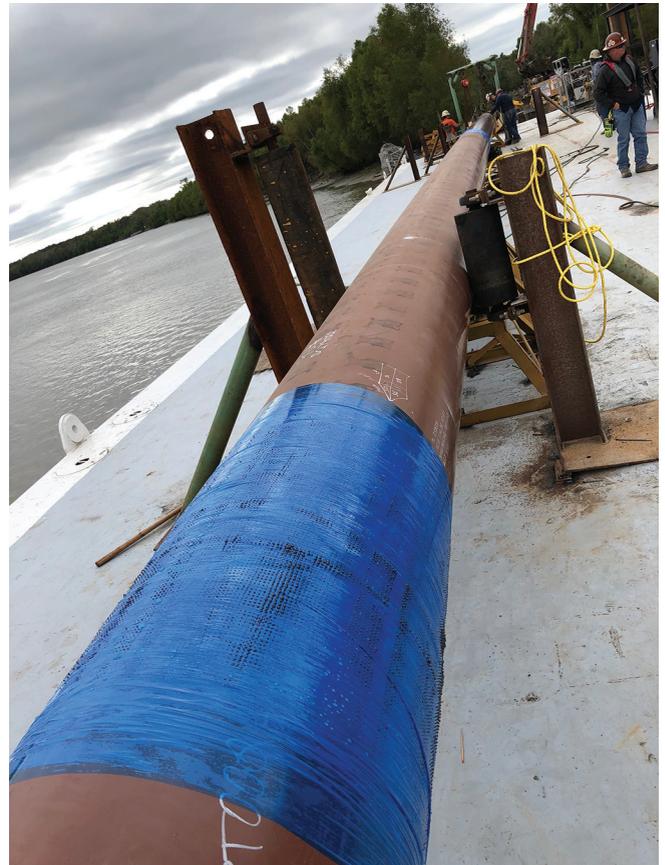
Technicians wrapped the pre-impregnated, tri-axial fiberglass laminate around the pipeline on the deck of a barge in preparation for installation.

used, a coating approved by the asset owner was applied to the line. Once the coating was set, technicians wrapped the pre-impregnated, tri-axial fiberglass laminate around the pipeline. Designed to set in approximately 30 minutes, the composite was applied quickly on the deck of the barge, allowing the pipeline to be installed without considerable delay. Because the sacrificial coating is highly resistant to degradation, it will enable a long service life by impeding corrosion.

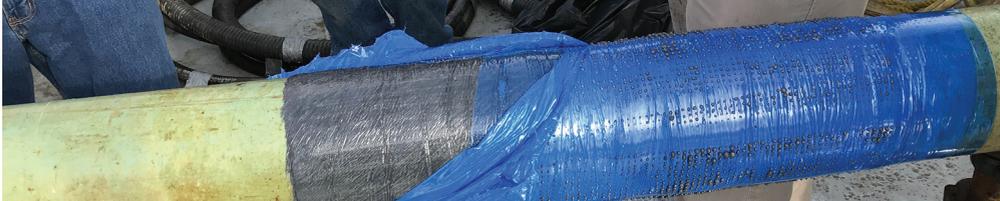
A disposable peel ply layer is applied at the end of each repair to protect the applied material. When the peel ply is removed, more layers can be added, or if the ECR is completely installed, can be coated or painted.

Applied on site by trained technicians, the fabric is wetted with resin, then applied to the pipe. The resin bonds the fabric in place, seals leaks, provides chemical resistance, and prevents further external corrosion. A disposable peel ply layer is applied at the end of each repair to protect the applied material. When the peel ply is removed, more layers can be added, or if the ECR is completely installed, can be coated or painted.
