Innovation overcomes installation and ageing problems

Clock Spring's casing spacers serve an important role in preserving pipeline integrity, offering certain advantages over traditional casing spacers.

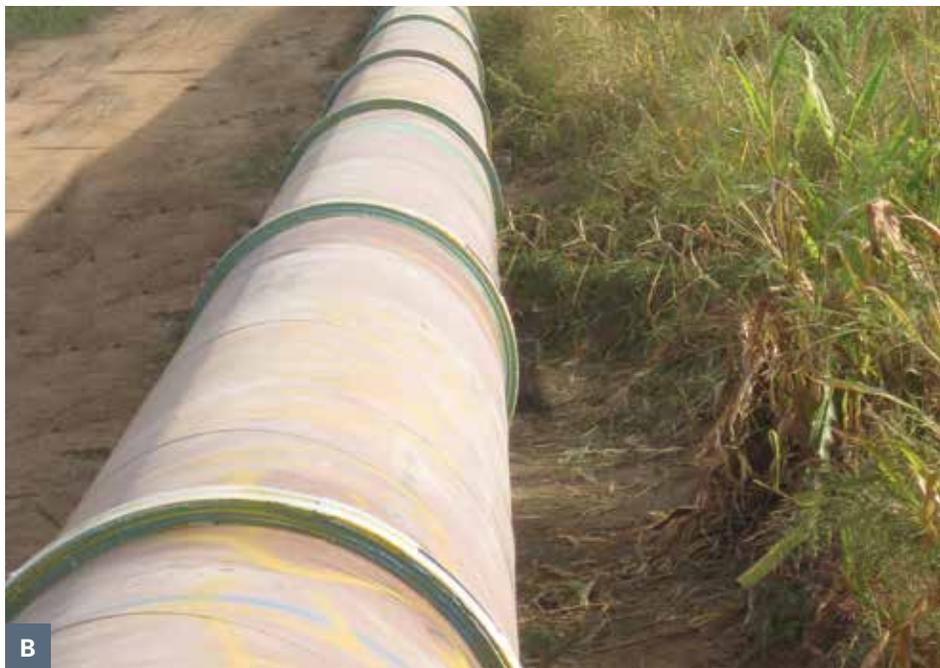
A: Workers installing the Clock Spring spacer system.

B: The Clock Spring composite pipeline reinforcement system in place.

Clock Spring's Casing Spacer comprises:

- » A unidirectional fiberglass sleeve sized for the specific pipe diameter
- » If needed, a high-strength, high-modulus

filler used to transfer load from the pipe to the sleeve

- » A methyl methacrylate-based adhesive, which has high lap shear strength, to keep the casing spacer secure.
