# AVT™ EZ VALVE®

ensured the water kept flowing at a hospital

## CASE STUDY:

Baton Rouge,  
Louisiana

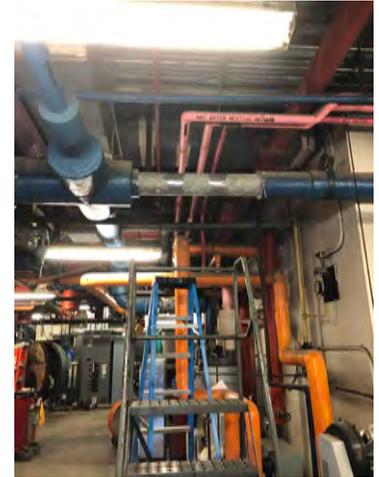
Pipe cleaned and taped, ready for install

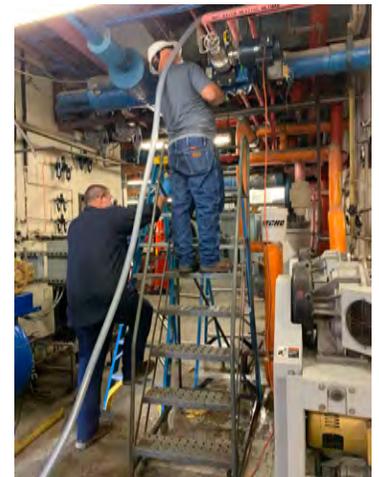
EM (end milling) machine in place ready for 120° slot to be milled

The EZ Valve is installed using a lightweight toolkit, which includes an EM (end milling) machine that is used to create a small 120° slot in the water pipe enabling the resilient wedge gate, that forms the water stop, to be placed into the pipe. This easy-to-maneuver equipment meant the awkward position of the valve's install location was not a challenge.

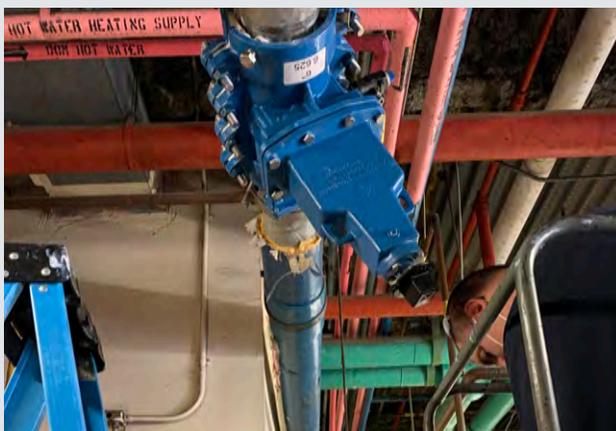
End rings and gear box removed, restraining bolts tightened, valve install complete

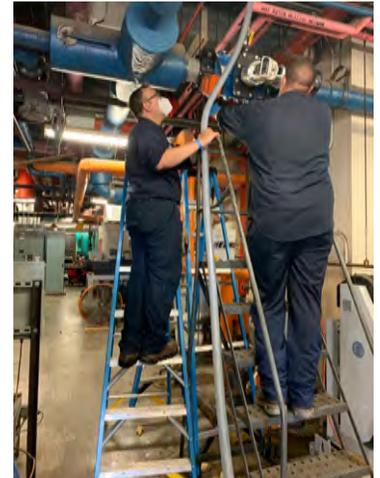
Steam & Process Repair's team ensuring the milling process runs smoothly

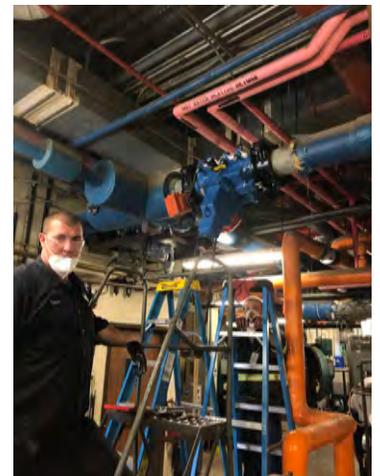
EM machine removed and valve bonnet in place
