CONCRETECLOTH™

Geosynthetic Cementitious Composite Mat (GCCM)

CASE STUDY:

Hunter Army Airfield Slope/Stream Bank Stabilization

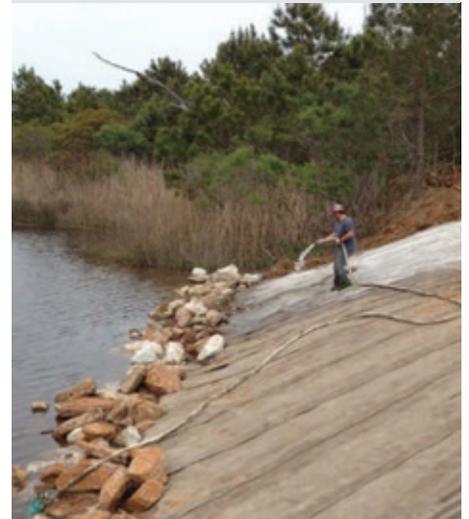
Concrete Cloth GCCM installed and hydrated on slope.

The site was graded and prepared as a smooth working surface, and the CC8 material was placed longitudinal on to the slope. The entire slope was covered and hydrated, after being toed in at the top and covered with large ballast at the bottom.

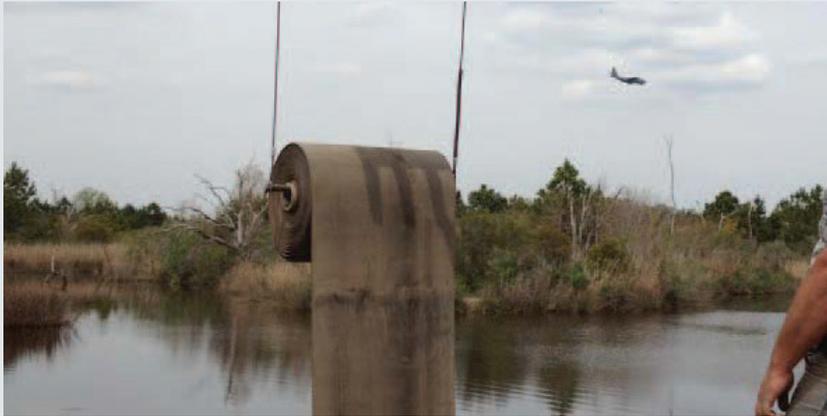
The installation was completed by three men and a trackhoe to lift the bulk roll.

The material was installed with a crew of three men and a trackhoe, using only simple hand tools to cut and seam the CC8. The two bulk rolls were placed by the contractor, who had no prior experience with Concrete Cloth GCCM. No specialty labor, forms or equipment were required.

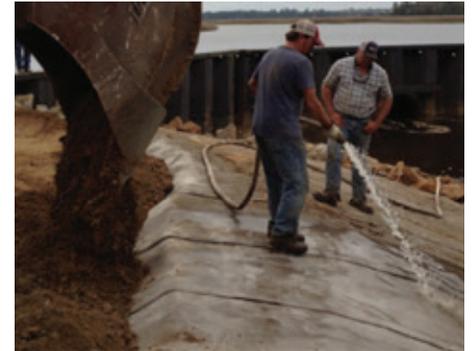
Concrete Cloth GCCM hydrated after installation.

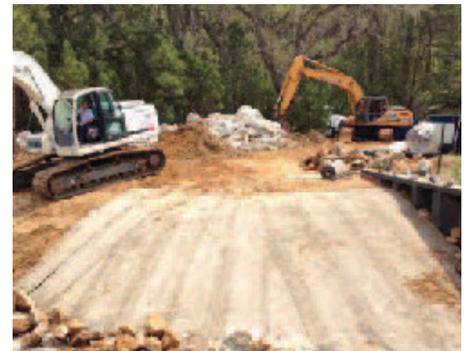
Concrete Cloth GCCM installed on the slope.

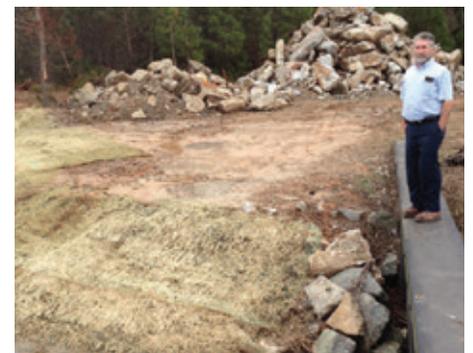
Vegetation on top of the Concrete Cloth GCCM after installation.
