CONCRETECLOTH™

CASE STUDY: Noble County Highway

Application: Culvert Invert Lining

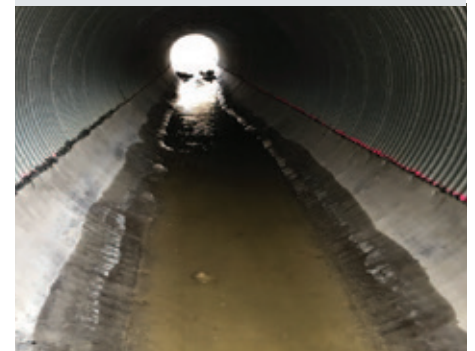
Rehabilitated culvert invert with CC8.

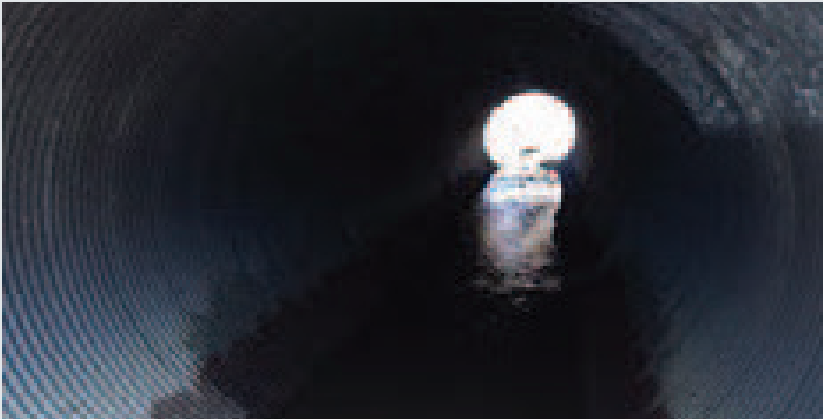
The invert of a 12' diameter CMP culvert in Noble County, IN, was experiencing minor pitting and rusting. The Noble County Highway Department needed a preventative solution to protect the invert from further abrasion and deterioration. The Highway Department wanted to make minor repairs instead of waiting for the culvert to get to a state beyond repair where replacement or major rehabilitation were the only options. GeoTree Solutions provided recommendations for the use of Concrete Cloth™ GCCM. A thickness of 8 mm (CC8) was chosen for the project. GeoTree assisted with the identification of the material quantity and offered on-site installation assistance for the job.

Existing invert with pitting and corrosion.

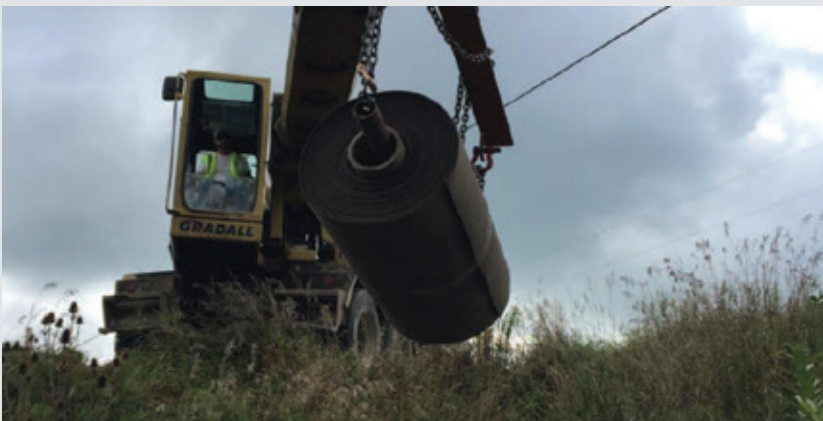
CC8 fabric roll lowered into culvert.

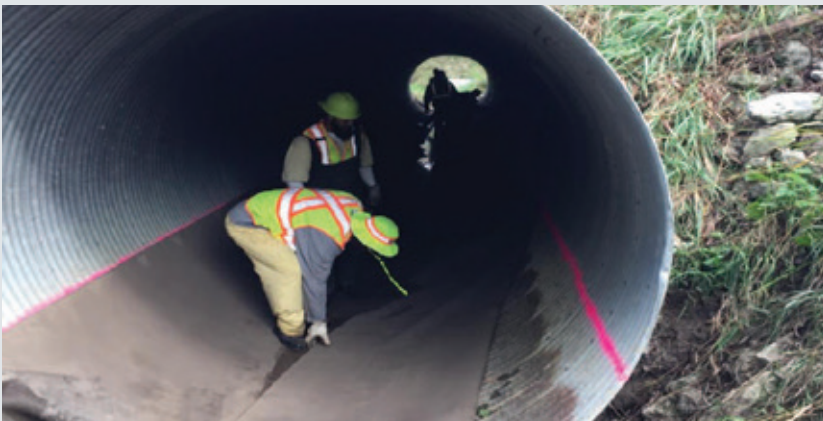
Laying CC8 sections longitudinally in invert.

It was decided that 3 panels of CC8 material could be laid longitudinally down the culvert to cover the desire area of the invert. The two side panels were first secured and then a center panel was laid atop the other two panels with significant overlap to prevent water ingress. The panels were secured with stainless steel screws to the culvert and sealed with a bitumen sealant. The Noble County maintenance crew longitudinally installed and hydrated 1000 square feet of the product in three hours. Lining the invert should extend the life of the culvert by significantly slowing down its deterioration rate. The Highway Department was pleased with the installation and wants to use the same fabric on several county metal culverts. The ability of the Highway Department to use their own maintenance crews to perform the work was a key cost saving for the project.

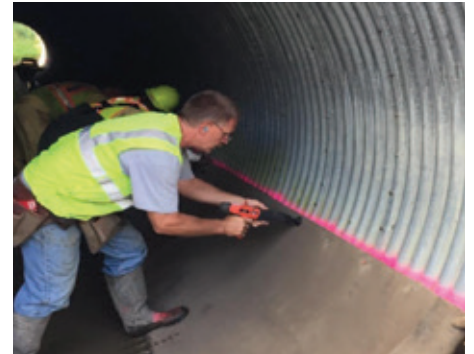
Securing CC8 with stainless steel screws.

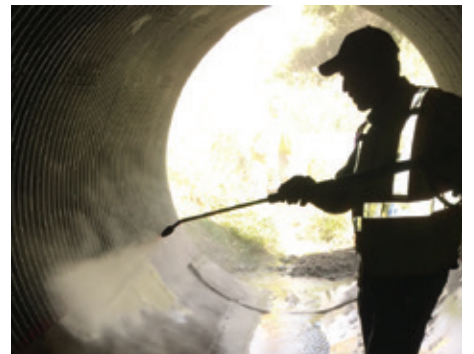
Hydrating CC8 to harden fabric.

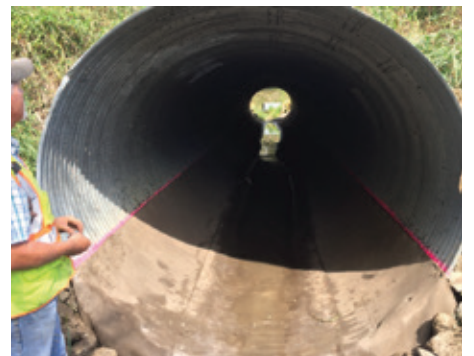
Completed rehabilitation.
