CONCRETECLOTH™

STRUCTURAL STRENGTHENING

CASE STUDY:

Wellington, CO Irrigation Collection

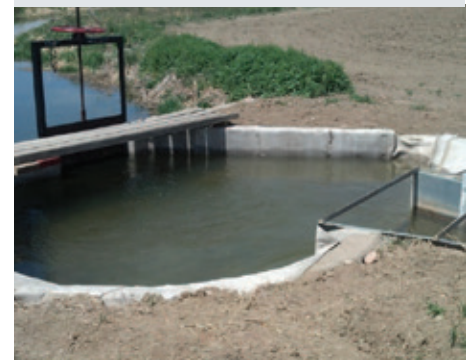
Filled irrigation collection and distribution structure after repair.

This irrigation company was pleased with the installation, and will likely use Concrete Cloth GCCM again in the near future, as it proved easy to handle, convenient to install with, and more cost-effective than the alternative replacement.

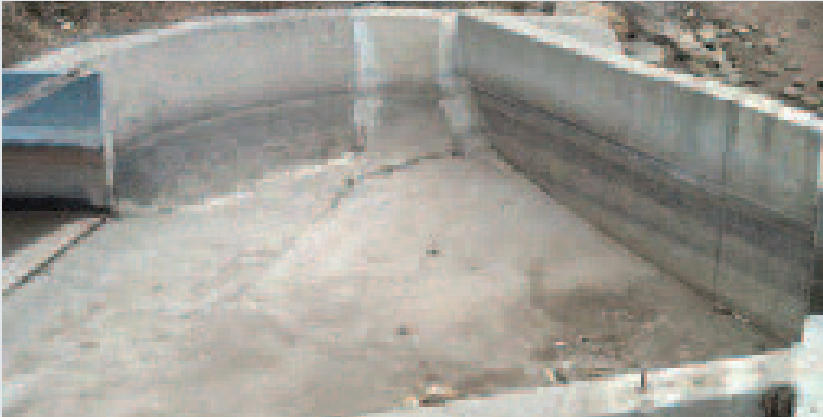
Existing damaged drainage structure prior to lining.

The company estimates it has as many as 200 structures in its network, and many are in need of repair. The aged concrete has cracked and is leaking, and in many cases the cost of replacement is expensive. As a result, the company is interested in a more cost effective solution to repair the structures.

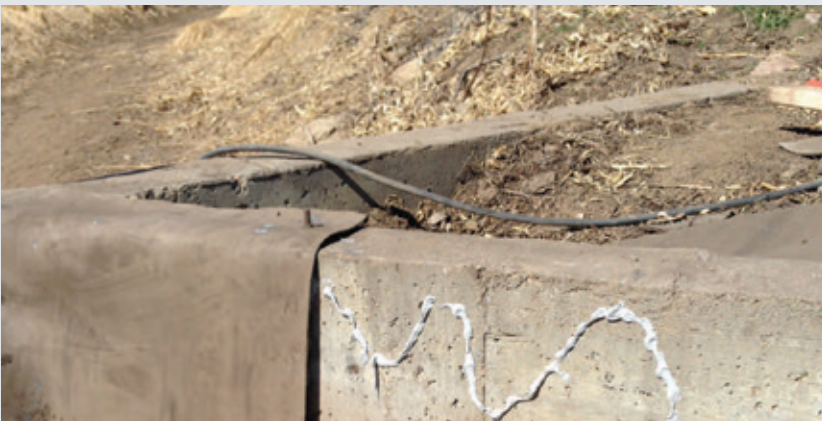
Adhesive applied to vertical wall for separate GCCM panels.

Day 1: The area was cleaned of debris, and then the layout was determined based on geometry and dimensions of the basin. In this case, the irregular shape led to a design where the bottom would be lined first, then separate panels would be installed on the walls of the structure. Concrete Cloth GCCM was cut to fit the bottom, laid in place and fastened. The panels on the walls were then glued and fastened using a nail gun. The entrance opening was affixed using a hold down bar fastened into the walls of the opening. Concrete Cloth GCCM was screwed together at many overlaps, and the completed installation was hydrated using a water truck. Watering was completed late the same day.

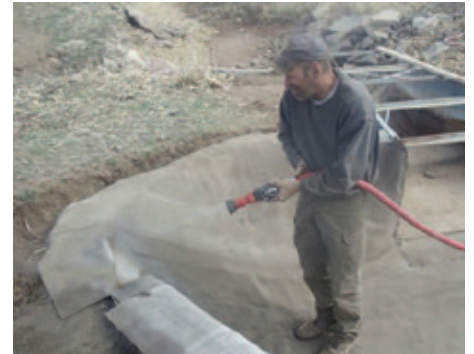
Hydration of repair site.

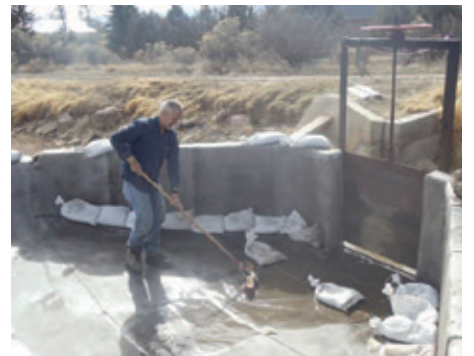
Brooming site to hydrate material.

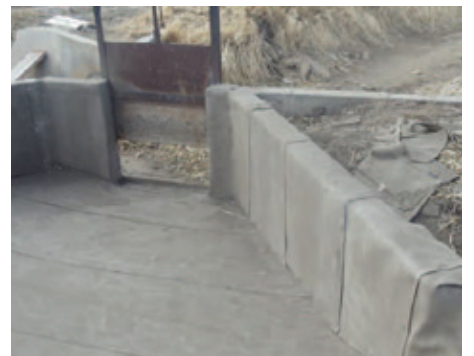
Repair site fully lined with Concrete Cloth GCCM.
