### PROJECT OVERVIEW

Wellington City Council was looking for a solution to repair the 1350-millimeter South Karori stormwater corrugated culvert. During the past 50 years of its service, the culvert's invert had fully degraded over its entire length (220 meters) from erosion and corrosion, with holes of up to 500 millimeters deep throughout the culvert. The culvert was installed simultaneously with the subdivision surrounding it, so it followed the natural stream bed, with four bends, vertical and horizontal deviations of up to 32 degrees and backfilled with up to 10 meters of cover.

**Location:** South Karori,  
Wellington, New Zealand

**Application:** Stormwater  
Corrugated Culvert

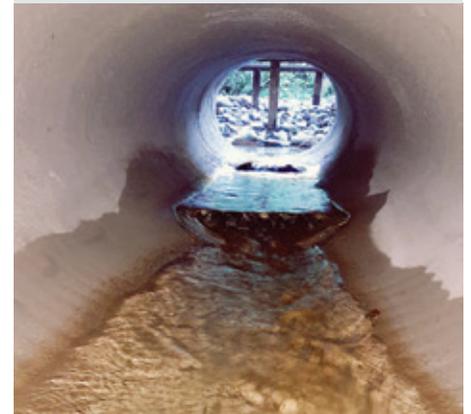
Completed project with Iris baffles installed as refuge for migrating fish.

After the GeoSpray mortar was applied, Flexible Iris baffles were installed to accommodate migrating fish, and riprap was placed on either side of the culvert for protection. The temporary access track was reinstated back to the environment through planting of local tree species, and the mountain bike track was lengthened and enhanced. The project was completed on time and within approved budgets, without any time extensions for inclement weather experienced during the contract.

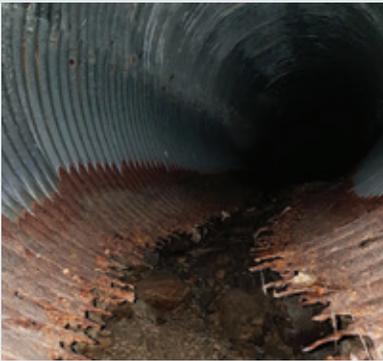
Condition of invert prior to GeoSpray coating.

CTNZ provided a solution in the form of a structural liner, which was formed using the GeoSpray system supplied by GeoTree Solutions. The repair area was cleared of any debris and the culvert bedding was reinstated. Then the invert was repaired using pumped concrete so the GeoSpray mortar could be applied. The project required various thicknesses along the length of the culvert, ranging from 42.5 to 50 millimeters.

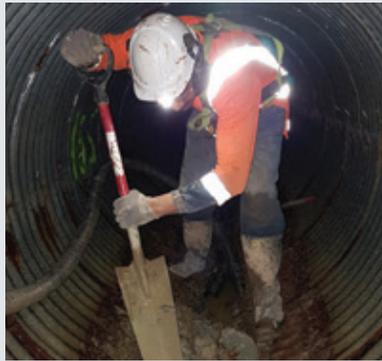
Excavation of debris within the culvert invert.

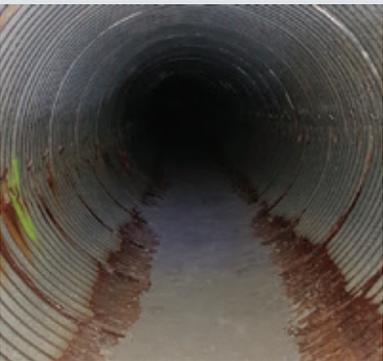
Invert repaired and ready for GeoSpray mortar casting.

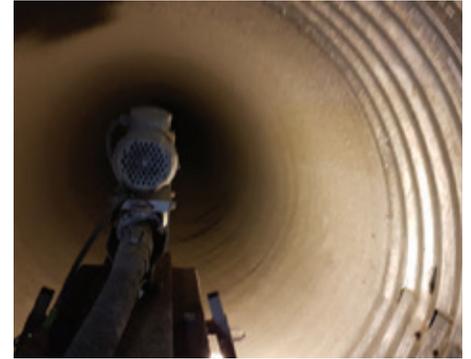
Centrifugal casting of GeoSpray mortar.

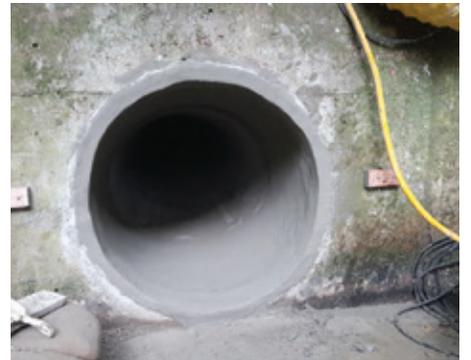
Completed lining with GeoSpray mortar at inlet.

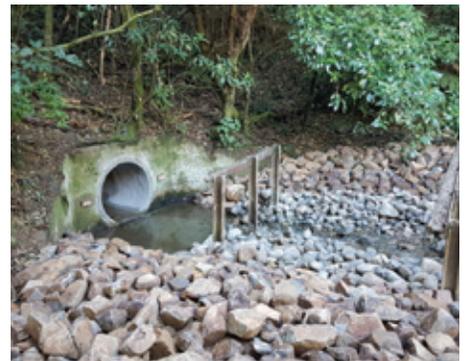
Completed culvert with GeoSpray mortar and riprap surrounding exterior.
