RENEWWRAP®

Carbon Fiber Strengthening System

CASE STUDY:

Greenville, SC Column Repair

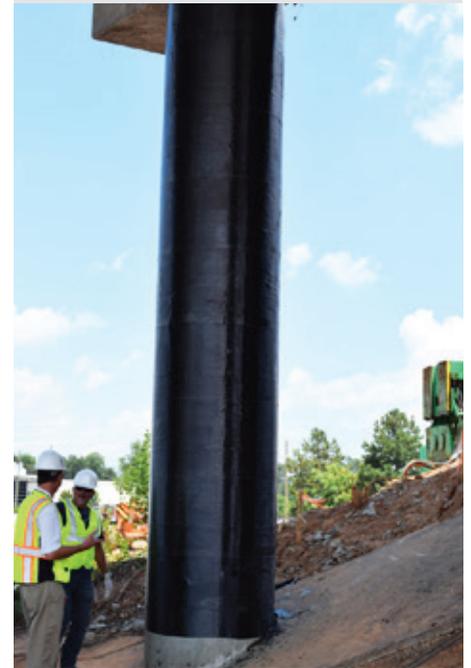
The RenewWrap system consists of high strength carbon fiber fabrics that are coated in the field with epoxy resins and bonded to or, in the case of the column repairs, wrapped around the structure to strengthen the member being repaired. The thousands of carbon fiber filaments in the FRP fabric perform the same function as reinforcing steel bars, but with the added advantage of being non-corrosive, which allows for placement directly on the surface of the columns.

Thanks to the minimal equipment requirements, the existing access area beneath the ramp was more than ample to perform the FRP installation. The crew cleaned the columns and patched small spalls to provide a uniform surface prior to installing the FRP.

OCS used multiple boom lifts to give them access to the entire column surface simultaneously, speeding repair time. The first column wrap was completed in about 8 hours over a two-day period, and subsequent columns were strengthened even faster.

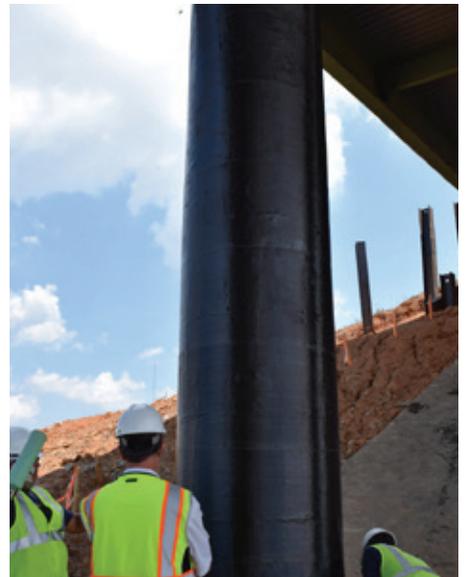
The first column was wrapped within eight hours
