COMPOSITE REPAIRS

This was the solution to a challenging repair undertaken by an Alaskan pipe operator that needed to address damage to 20 girth weld joints on a 10in (254mm) gas pipeline in Cook Inlet. The line needed to be repaired without disrupting service, but that was only one of many considerations that had to be taken into account in the operation.

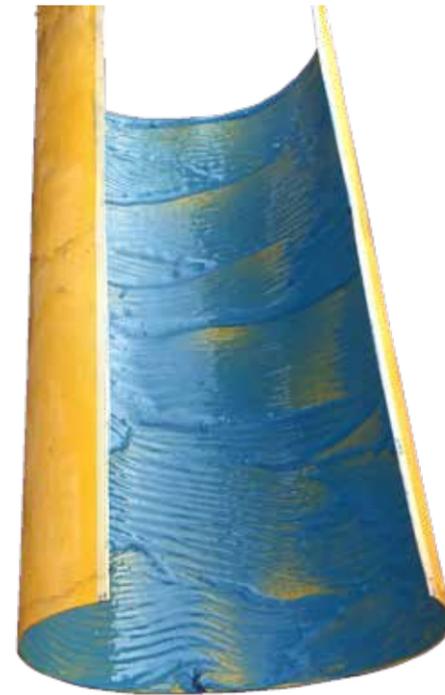
Another was difficulties posed by the subsurface conditions. There was zero underwater visibility at the repair site 100ft (30.5m) below the surface, and in addition, there was very little clearance between the lines. The pipeline had a 2in (5cm) thick concrete coating, which, in some cases, left only 2in of clearance.

The SnapWrap split sleeve can be placed over the damaged area of the pipe and permanently affixed without the need for cutting or welding.

This multi-layered high-strength, corrosion-resistant sleeve is coated internally with a high-performance adhesive and filler material combination designed to bond with the mother pipe. For underwater repairs, a diver can swim to the subsea pipe, place the prepared lightweight sleeve on the pipeline and secure it until it is properly cured for a durable repair. The diver can return to the surface for the next section and continue the process until the damaged pipe is completely restored.

During the operation, the diver carried the Snap Wrap sleeve with the filler/adhesive from the barge to the pipeline and manoeuvred it into position, wiping the excess filler from the sides of sleeve and placing wrap ties around the finished repair to hold it firmly in place while it cured.
