# 100-YEAR-OLD PENSTOCK GIVEN NEW LEASE OF LIFE BY TYFO SYSTEM

Location: Town of Dryden, Ontario, Canada

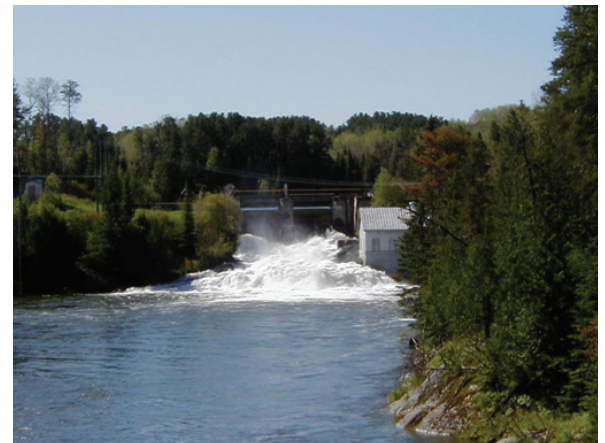
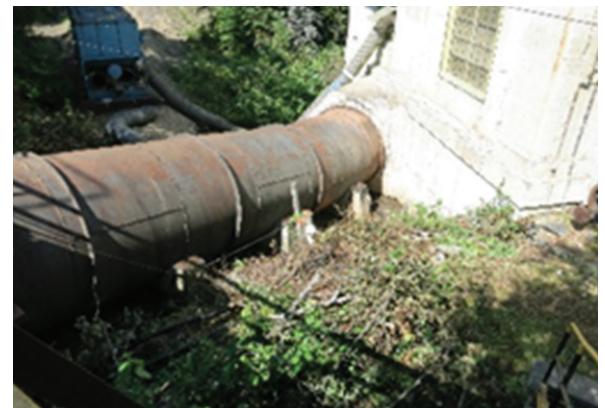
The Eagle River penstock is aboveground, supported on concrete piers and exposed everywhere except for the end terminations which are encased in concrete. KSS Group assessed steel thickness and identified deficiencies, which included severe wall loss and holes through the pipe wall. The assessment concluded that the steel pipe required immediate rehabilitation for a 72.5-foot long section between the intake structure and the powerhouse.

The owner conducted feasibility studies and decided to rehabilitate the deficient pipe sections with Fiber Reinforced Polymers (FRP) instead of using the traditional remove-and-replace options or extensive welding repair options.
