100-YEAR-OLD PENSTOCK GIVEN NEW LEASE OF LIFE BY TYFO SYSTEM

Location: Town of Dryden, Ontario, Canada

The Eagle River Generation Station is a hydroelectric generating station located near the Town of Dryden, Ontario, Canada. Eagle River, in addition to McKenzie and Wainwright stations, provide a combined 3.9 MW of energy to the local power grid. These generating stations make up Dryden Hydro and are owned by the Capstone Infrastructure Corporation. Built in 1920s, the 120-inch diameter riveted steel penstock delivers water from Eagle River to the hydro turbine.

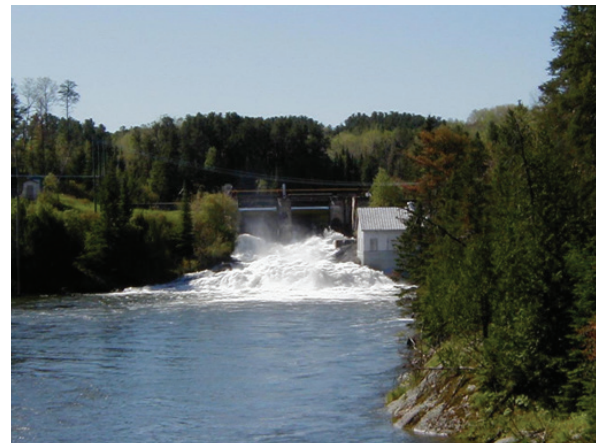
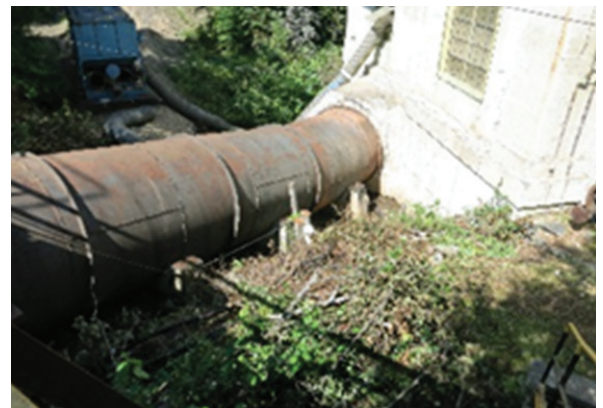
The Eagle River penstock is aboveground, supported on concrete piers and exposed everywhere except for the end terminations which are encased in concrete. KSS Group assessed steel thickness and identified deficiencies, which included severe wall loss and holes through the pipe wall. The assessment concluded that the steel pipe required immediate rehabilitation for a 72.5-foot long section between the intake structure and the powerhouse.

The owner conducted feasibility studies and decided to rehabilitate the deficient pipe sections with Fiber Reinforced Polymers (FRP) instead of using the traditional remove-and-replace options or extensive welding repair options.

Tyfo FRP products were selected to act as a standalone structure without relying on the strength of the host pipe. The full-structural design was completed per the recommendation of the AWWA Draft Standard for CFRP Renewal and Strengthening of PCCP basing the design on load and resistance factor design (LRFD), now AWA C305. Fyfe needed to ensure the design could meet the following demands:
