# BUCKLED AND DEFORMED PENSTOCK REHABILITATION TO RESOLVE POWER GENERATION ISSUE

*Location: Almonte, Ontario, Canada*

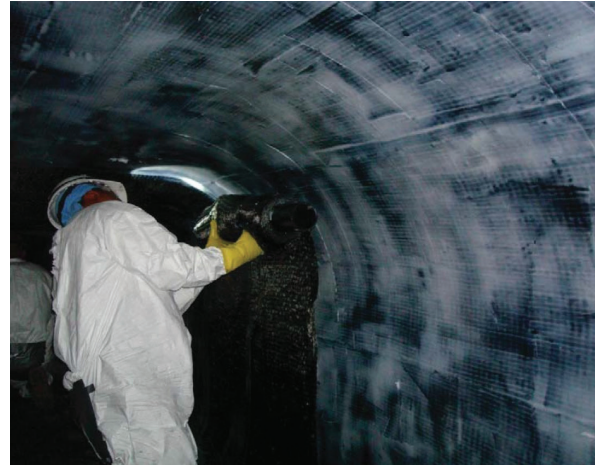
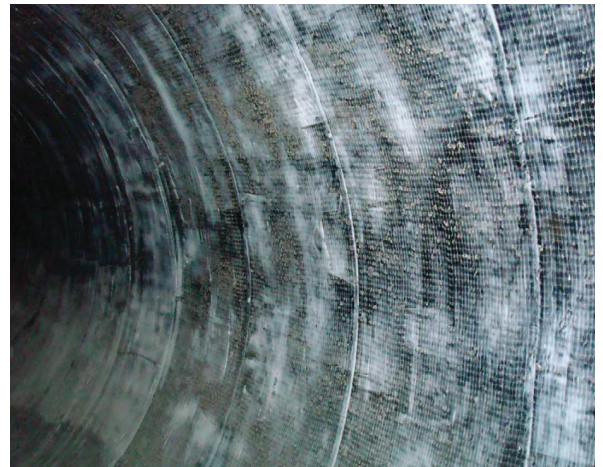
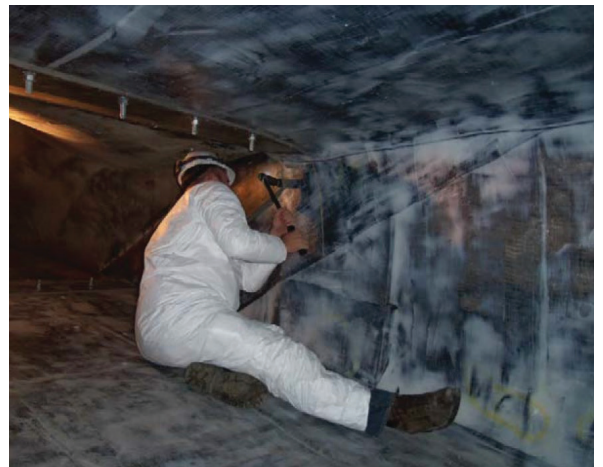
The project faced a variety of challenges during the project including leaks and water infiltration. Eliminating these leaks was critical to the success of this project, so leaks were repaired prior to installation, and water infiltration addressed throughout the course of installation.

Due to the rectangular transition cross-section, a unique end termination was developed using stainless steel anchors embedded in concrete with clamp bars to protect the leading edge of the FRP fiber system and prevent water from migrating behind. The repair's end termination in the 106" diameter liner used a conventional WEKO seal common in most pipe repairs.

Field quality inspections confirmed the prepared surface profile and insured adequate bond could be developed between the concrete substrate and FRP laminate after adhesion testing. Together with the engineered, end termination detailing and installed CFRP anchors, the CFRP repairs will provide a structural liner capable of resisting the design pressures without water migrating behind the liner and buckling. The FRP solution will provide several decades of service life and continued power generation for the facility.
