Clock Spring Contour Repair Topside Piping System Corrosion

Pipe Details

- 26-inch (660-mm) topside production piping system
- Severe external corrosion

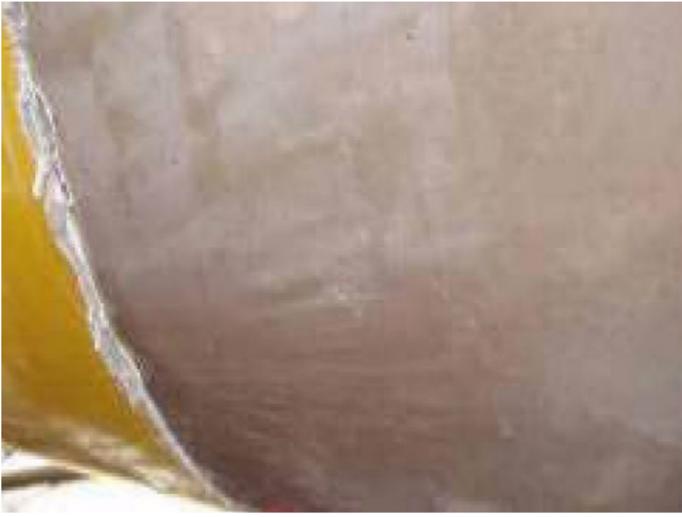
Due to the server extent of the corrosion the high compressive strength filler was initially hand applied

A team of Clock Spring trained and certified technicians installed standard Clock Spring 8-layer pre-cured coil sleeves to all straight piping sections, pipe supports, girth welds and 12-inch (305-mm) offtake systems. Because of the severe extent of the corrosion, installers applied high compressive strength filler by hand, molding it in place for curing prior to installing the Clock Spring coils.
