Clock Spring Provides Permanent Repair to Damaged Refinery Pipeline

Pipe Details

- 8-inch (203-mm) diameter pipe
- Air/Gas mixture
- 900 feet (274 m) of pipeline

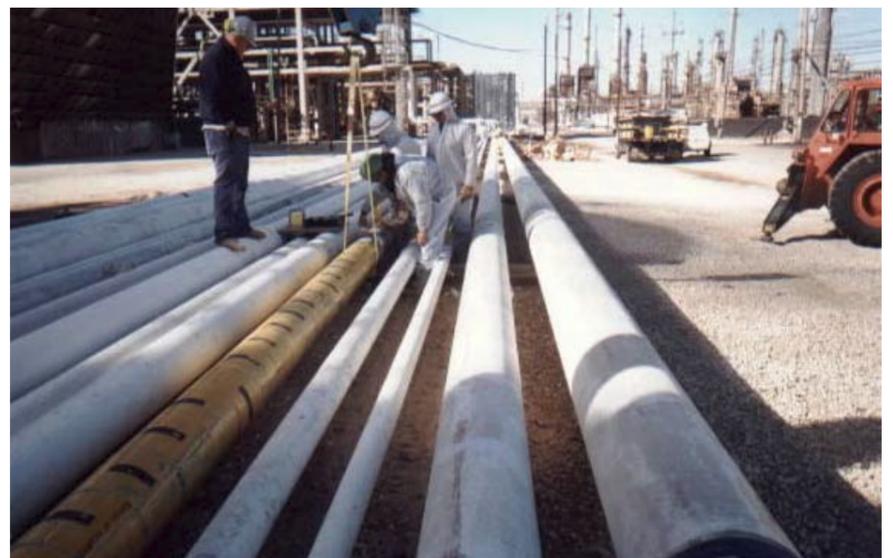
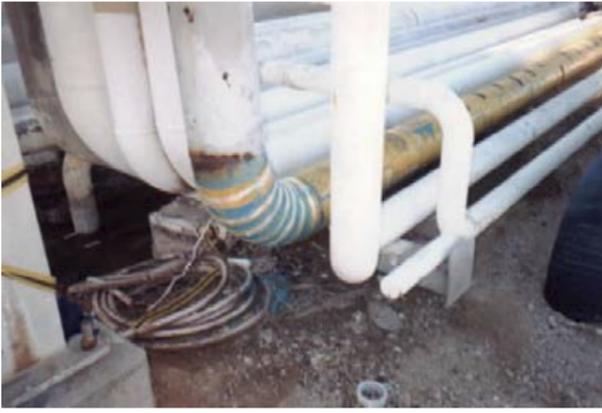
A US refinery discovered that a segment of aboveground pipeline had sustained corrosion from an airborne drift from a cooling tower. Damage was extensive. Corrosion spots covered 900 feet (274 m) of line that ran parallel to the tower.

A team of Clock Spring trained technicians installed 903 Clock Spring units over 900 feet (274 m) of pipe at approximately 75 feet (23 m) to 100 feet (30 m) per day. As a cleaning crew prepped the pipe, three installation crews applied the Clock Spring to areas that included 90-degree and 45-degree fittings.
