Clock Spring Repairs 42-inch Suction Line at Storage Terminal

Pipe Details

- 42-inch (1,067 mm) suction line at a storage terminal
- Extensive pitting and corrosion

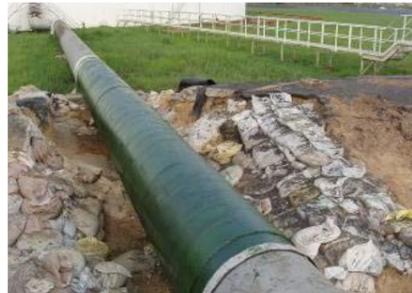
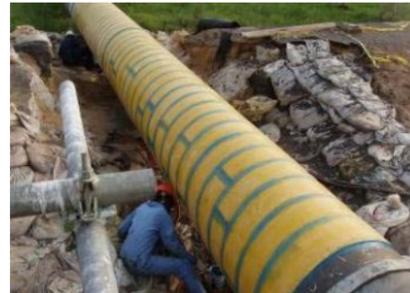
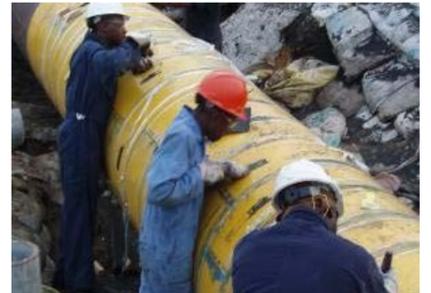
The coil tightened using the cinch bar to extrude excess filler and adhesive.

With the pipe properly cleaned, the team applied the Clock Spring starter pad and began installation of the Clock Spring units using a spool feeder because of the pipe diameter and limited clearance underneath the line. Once the coil was wound around the pipe and adhesive was applied to the complete surface area of the coil, installers slid the sleeve into place over the filler and onto the starter pad. The coils were installed side by side to accommodate the complete repair length and external extent of the corrosion. Each coil was tightened using the cinch bar to extrude excess filler and adhesive and ensure all the voids were filled completely.
