# Clock Spring Repairs Dent Due to Rockfall in Hydro-Electric Pipeline

### Pipe Details

- 914-mm (36-inch) diameter API 5L Grade X60  
70 Bar (1,015 psi) design pressure.
- 30 mm (1.18 inch) original wall thickness.
- Dent caused by ground movement.
- Access by 75-minute walk or by helicopter only

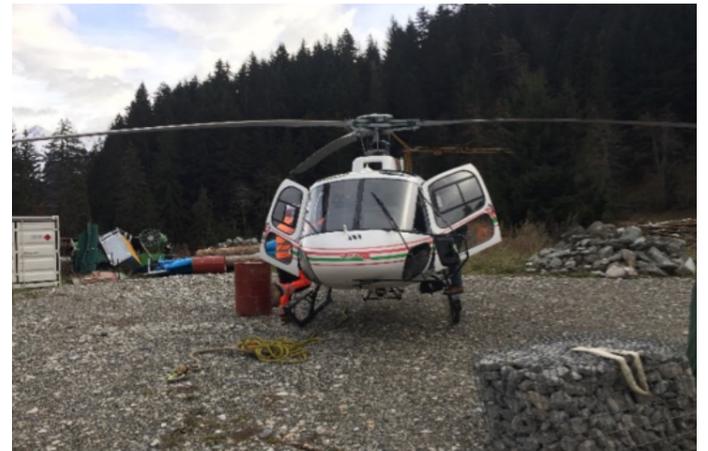
*Mobilisation of all equipment by helicopter.*

A helicopter delivered the necessary repair equipment and the installation team to the work site, where the Clock Spring trained technicians grit blasted the damaged area of the pipeline to a finish of SA2.5, removing all rust, coating, and mill scale to produce a near-white surface, and washed it with solvent before inspecting for crack-like features that would indicate additional damage.
