Contour Addresses Internal Erosion on Offshore Production Unit

West Africa

Pipe Details

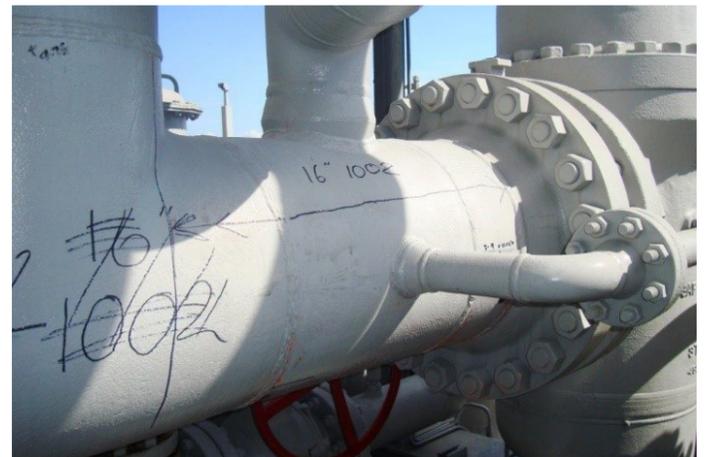
NDT inspection revealed several severe internal defects in a 406-mm (16-inch) line running into the main high-pressure separator on an offshore production facility. The erosion was significant, affecting multiple places along the pipe and growing at such a rate that imminent failure was likely. If the damage were to reach a critical point, the platform would have to be shut in, resulting in a huge loss of production. In addition to the financial impact, there was potential for considerable environmental impact in the event the eroded pipe developed a leak.

Internal Erosion Completed Repair

A team of Clock Spring trained technicians cleaned the section of damaged line using power tools to remove the external coating and then bristle blasted it to create a surface profile equivalent to SA2.5 before applying the Contour repair.
