Contour Corrects Internal Erosion Defect Offshore

West Africa

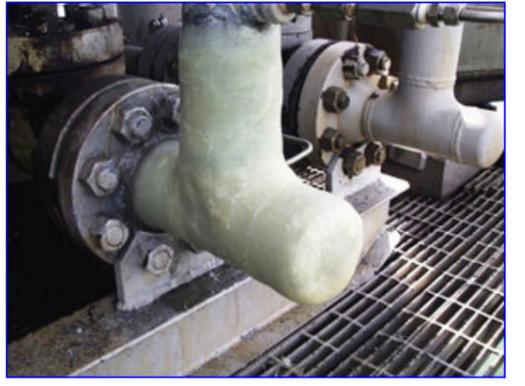
The team of 2 technicians completed the repair over the course of 2 days following standard installation procedures, restoring the integrity of the line without introducing additional risks, allowing regular operations to resume.
