# Contour Restores Gas Line for 20 More Years of Service

### Pipe Details

- Two sections of an API 5L Grade B gas pipeline had suffered damage from external corrosion
- 50.8-mm (2-inch) diameter line was damaged over a 1,829-mm (6-ft) straight run of pipe
- 114.3-mm (4.5-inch) diameter line was damaged over a length of 2 m (6.56 ft) that extended along a straight run and an elbow
- Corrosion had caused wall loss up to 51% on both lines
- 75.8 bar (1,100 psi) design pressure
- 25°C (77°F) design temperature.

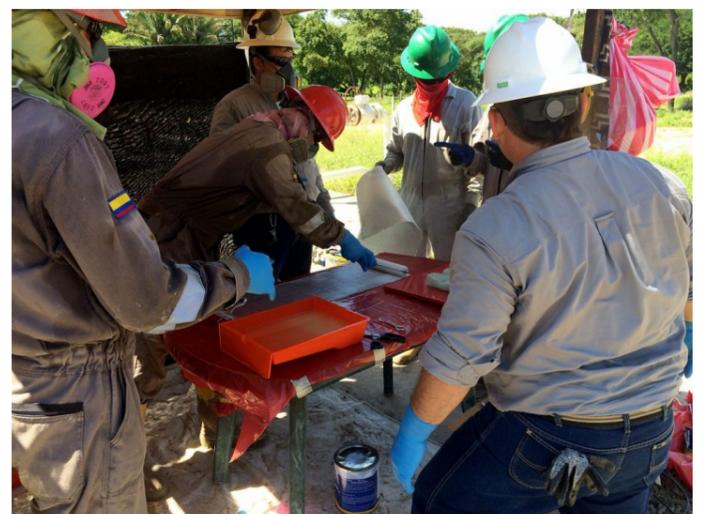
- External corrosion on two sections of gas pipeline with different diameters and geometry
- Corrosion resulted in wall thinning to 51%
- 5 local trained technicians completed the Contour installation in only 3 hours
- The repair is designed for 20 years of safe service
- No hot work required
- No negative environmental consequences

The first step of the job was to remove the coating from the pipes and prepare the surface. A rotative reamer was used to obtain medium roughness (~ 3 to 4 mills) on the repair areas to provide an appropriate surface for applying the composite solution. While the surface preparation was under way, a small table was set up and covered with plastic film to provide a work surface where installers would prepare the Contour for application on the damaged lines.

The epoxy and resin were mixed on site so the technicians could saturate one fiberglass band at a time using a paint roller. When a number of saturated bands were prepared for application, the technicians placed them one at a time on the pipe, following a herringbone pattern (50% axial overlap), taking special care to prevent any foreign matter from becoming trapped in the fabric and avoiding blisters, pits, wrinkles, pin holes, sagging sections (particularly on the bottom of pipe), and dry spots. When the appropriate number of layers were installed along the damaged areas, the Morken technicians placed a peel ply on top of the composite. The installation team completed the repair in only 3 hours.

Although the technicians allowed the peel ply to remain in place overnight, the repair cured to 74 Shore D hardness and was ready for service in approximately 5 hours.
