Clock Spring Repairs Risers on Offshore Platform

Pipe Details

Summary

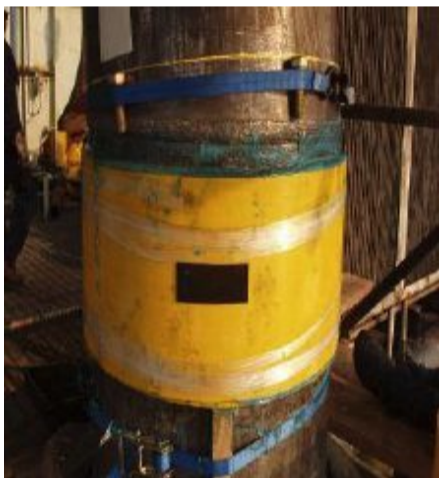
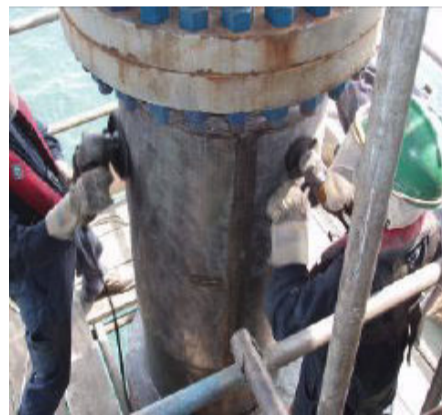
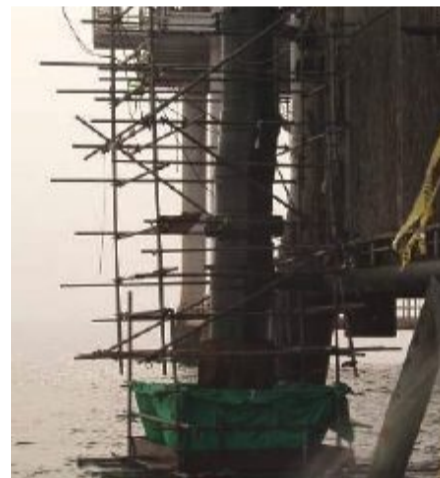
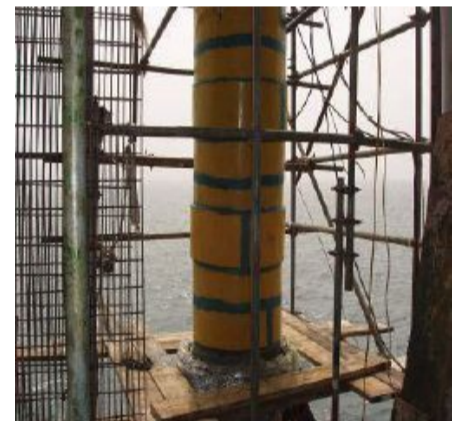
Risers on an oil platform offshore Africa had sustained corrosion damage and needed repair along a section of pipe that had been welded, producing a surface that was not aligned. Clock Spring had to contend with alignment and weld bridges in the course of addressing corrosion concerns.

A Clock Spring trained and certified team began this complex project by positioning a clamp at the +10 riser location, which was required before the weld bridge could be created. A steel sleeve repair had been welded previously, creating two diameters at this point in the riser. While the differing diameters needed to be addressed, they would pose no impediment to the eventual installation of the Clock Spring repair.

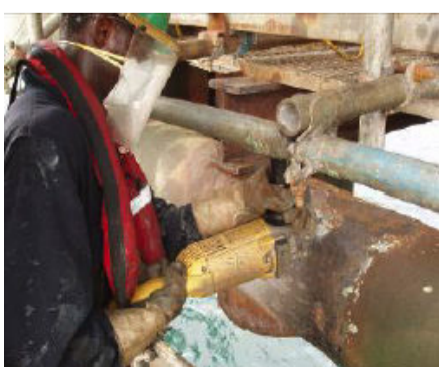
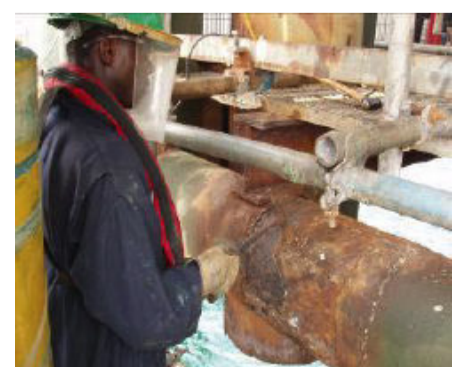
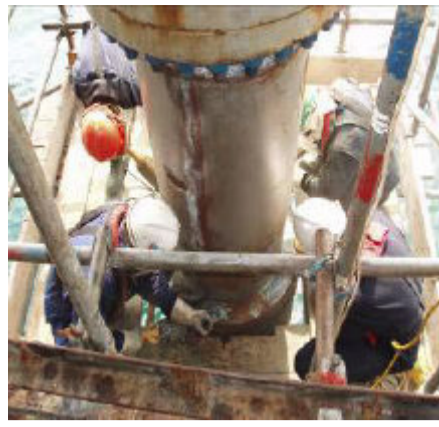
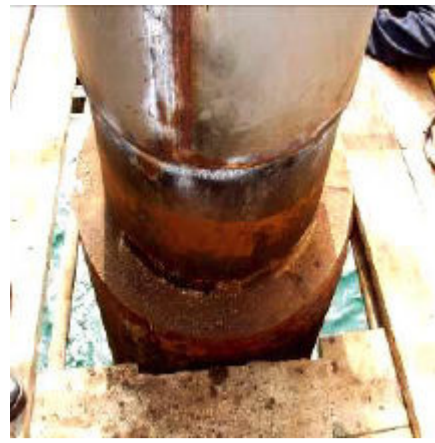
The installation team used 7-inch (178-mm) grinding machines fitted with wire wheels to prepare large surface areas and 4-inch (102-mm) machines for the welds and areas that were more difficult to access. The surfaces were cleaned to a NACE 3 standard, producing a clean white metal surface with all contaminants removed. With the surface prepared, the riser was ready for Clock Spring repairs both above and below the welded steel sleeve.

During the complete installation process, the flanges were covered to prevent adhesive from falling into the flange web and bolts, which saved time in the final cleaning process.

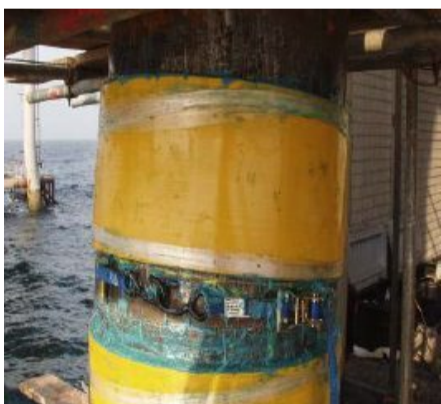
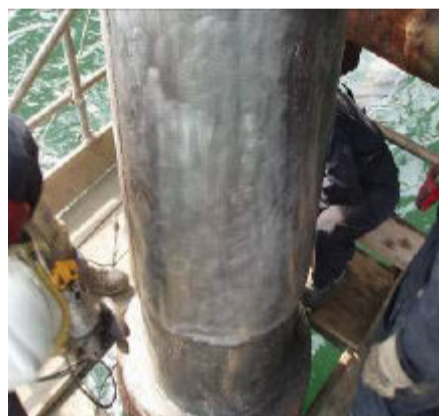
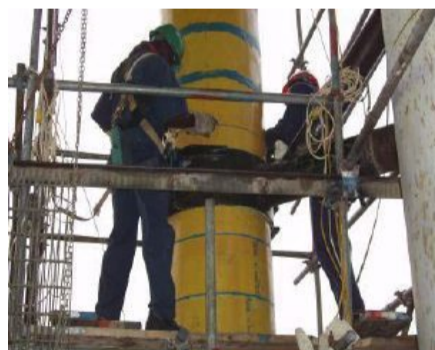
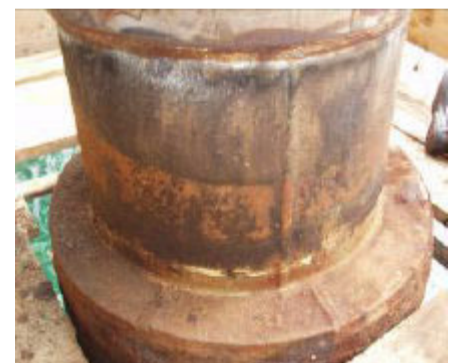
With the second Clock Spring installed, the gap between them was ready to be filled. The installation team applied filler over the two welds and affixed the molds, tightening them to force the filler into the natural circumference of the pipe. When the mold was removed, installers sanded the cured filler and refilled the voids, allowing the new filler to cure. This created a new surface that would allow the Clock Spring to be installed without voids and cavities. This precaution allowed the Clock Spring to keep its hoop stress.

With the two weld bridges completed, the final stage of the Clock Spring installation was carried out. The team cleaned the Clock Spring in readiness for the corrosion coating and applied primer to the joints on the repair sleeve, allowing it to cure before applying the final coating. The flanges and both clamps also were coated to create a fully coated finished surface.
