# LARGE DIAMETER PCCP REHABILITATION

## Fayette Power Station, Lower Colorado

## PROJECT PROFILE: PIPELINE REHABILITATION TYFO® SYSTEM

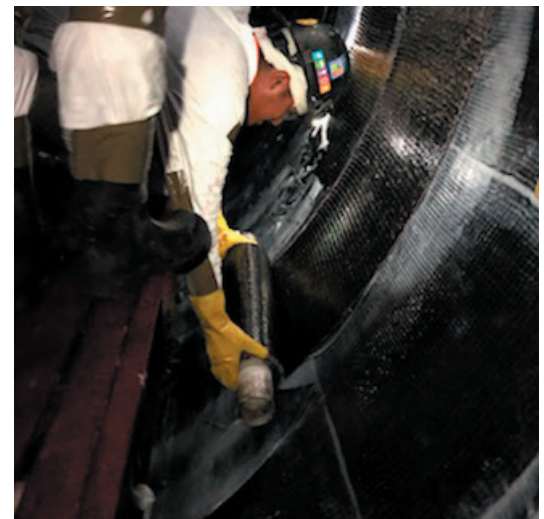
Tyfo® unidirectional carbon fiber being placed and oriented in the hoop direction on the 120-inch PCCP pipeline

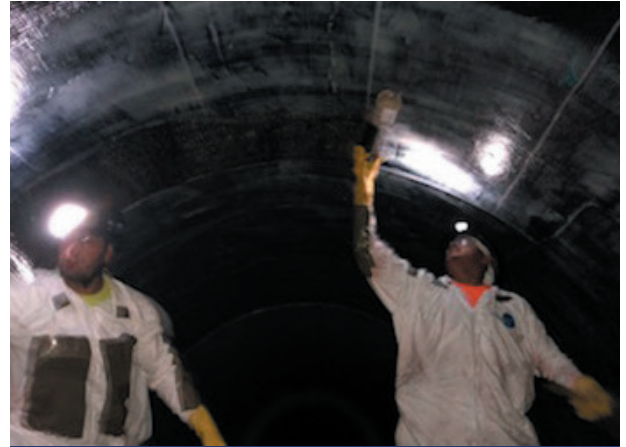
Tyfo(r) CFRP being placed in the hoop direction.

5. Placed the hoop layers of the CFRP system in narrow widths as needed to conform to sloped surface in joint recess. Staggered the seams of the narrow hoop layers in subsequent layers.

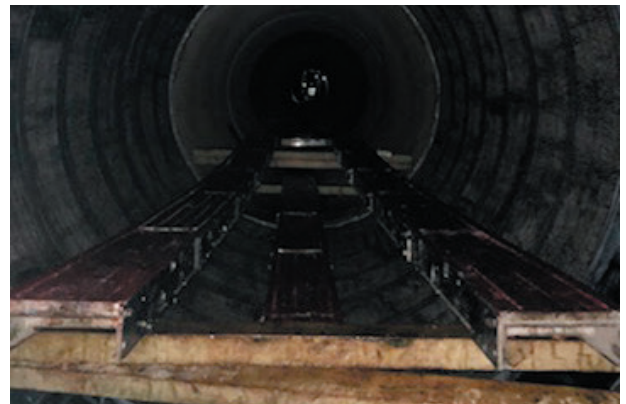
Scaffolding is used to provide work access to apply the Tyfo® CFRP product
