# PROJECT PROFILE: PIPE REHABILITATION LOCTITE TYFO SYSTEM

## INTERMOUNTAIN POWER PLANT

### UNIT 1 CW PIPING REHABILITATION

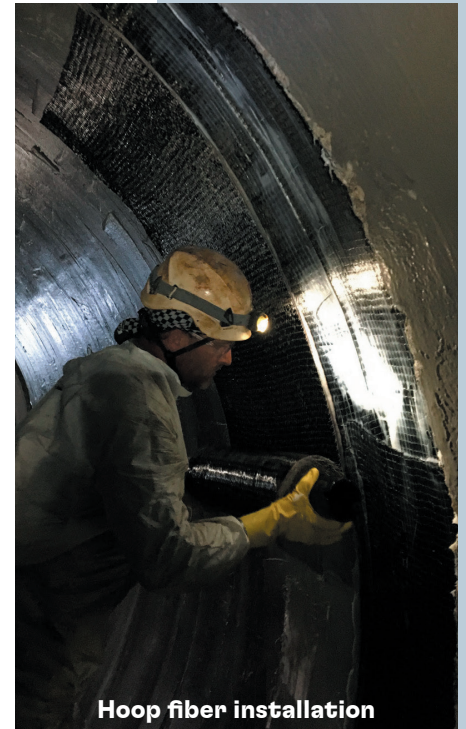
**Hoop fiber installation**

3. Remove mortar lining at joint ends, at least 18 inches to the steel can, for proper termination of the CFRP system.
4. Install CFRP layers in the hoop and longitudinal directions as required by the AWWA C305 design requirements.
