Composite Sleeves Address Mechanical Damage to Pipelines

By [Buddy Powers](#), Vice President, Product Management and Technical Services, **Clock Spring**, Houston, TX

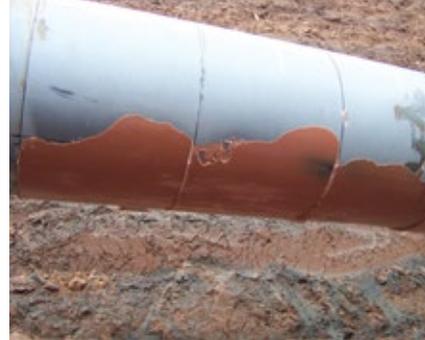
The 1997 GRI Report No. GRI 97-0143, *Evaluation of a Composite System for the repair of mechanical damage in Gas*

Transmission Lines, involved full-scale tests completed on 12-inch diameter pipe with D/t ratios of 51 and 68 having 15% dents with gouges. Pressure cycles were initially applied between 0 and 50% MAOP for 50,000 cycles, and then between 0 and 100% MAOP until failure. The results showed that the Clock Spring repair system procedure was effective in increasing the fatigue life for the repaired defects by two orders of magnitude when compared to unrepaired sections.

In addition, Clock Spring products were installed over several pipe diameters with increased D/t ratios (96) and gouged depths (30% and 50% of the wall) with repairs applied at 0%, 50%, and 90% MAOP were cycled to prove acceptable fatigue of over 250,000 cycles. Fatigue testing indicates that composite repair sleeves extend fatigue life by an order of magnitude over grinding as the sole repair. The results of this study provided several important insights as to the importance of inspection and the removal of cracks or stress risers from the defect.

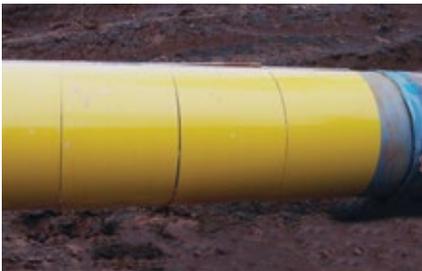
Clock Spring composite sleeves are installed by certified technicians in three relatively quick steps. The pipeline does not need

to be shut down during the repair process.

Step 1: Pipe preparation – Commercial sand blast to remove coating, removal of stress concentrators in accordance with applicable codes and inspect dent area for surface cracking.

Step 2: Molding the filler into defected area – This incompressible material fills the dent area and acts as a load-transfer agent to transfer the stresses from the pipe to the composite sleeve. If molded, a visual inspection before the installation of the surface can verify good fit-up of the sleeve.

Step 3: Fit the composite sleeve onto the pipe and cinch it down to ensure maximum strength in repair.

Once these steps are complete the composite will cure within one hour and the pipe is ready to be recoated and backfilled.

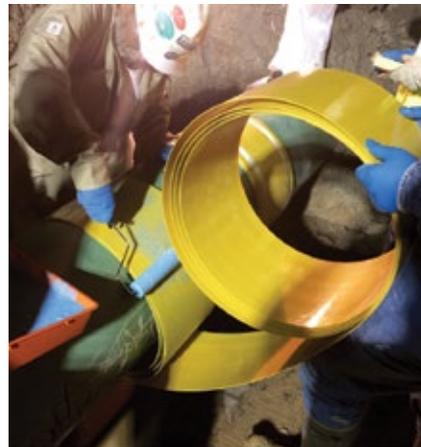
An example of addressing this threat using the above procedure for repair

features a molding step before the installation of a Clock Spring repair sleeve. An 8% dent with a gouge approximately 10 inches long was dressed to remove stress concentrators and prepared before a single-wrap mold formed the filler material in the dent region, building back the ovality of the pipeline. The molding step ensured constraint of the dent once the repair sleeve was installed.
