## ALLSTATE TOWER WRAP

### Repairing Old Foundations

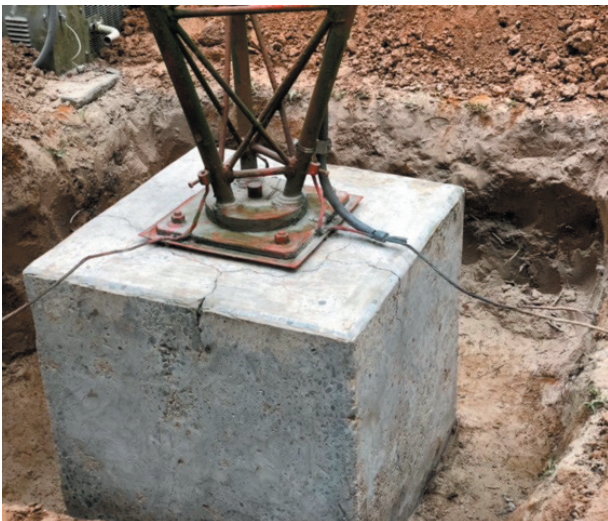
Concrete cleaned and prepped.

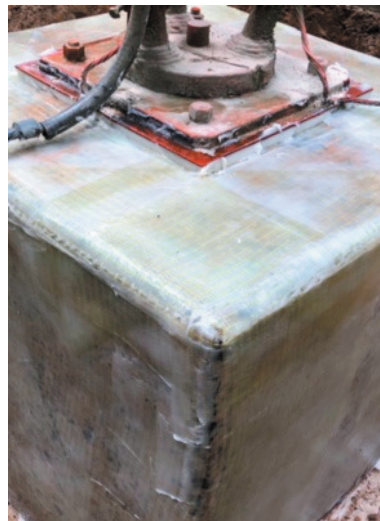
Concrete foundation with FRP applied

As part of a rehabilitation of a series of utility towers, the structural engineer recommended repairs to the foundations. The concrete footing needed to be excavated, repaired and backfilled. Engineers called for a Tyfo® fiber-reinforced polymer (FRP) system to wrap the concrete after it was repaired. The glass FRP system was designed to protect and confine the concrete from the elements and deterioration underground. This was a cost-effective and simple solution to prevent the need for further repairs in the future to this foundation. Allstate Tower coordinated with the engineer and OTB Contracting to install the Tyfo® SEH-51 system.

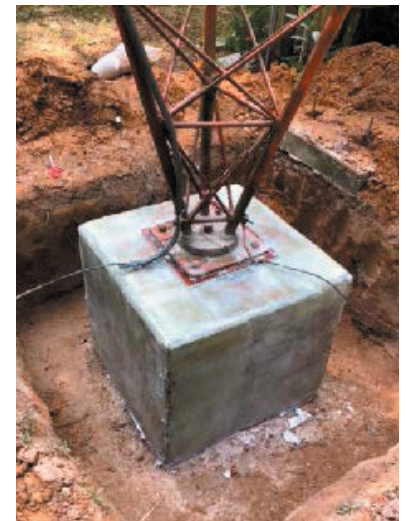
General view of foundation
