# Clock Spring Repairs Damaged Girth Weld

### Pipe Details

- 305 mm (12-in) high-pressure gas pipeline
- 9.52 mm (0.37-in) wall
- 68 bar (980 psi) operating pressure
- 22° C (72° F) operating temperature

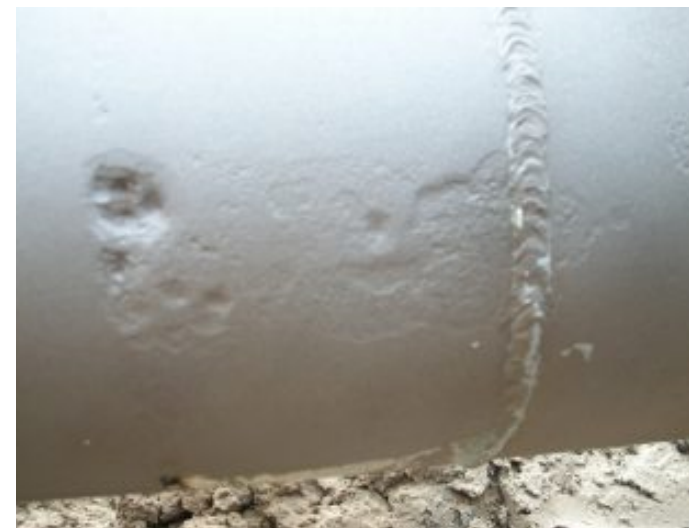
During an inspection, workers discovered a defect in a high-pressure gas pipeline. Corrosion was extensive, with significant damage adjacent to the circumferential girth weld, where there was as much as 74% metal loss. Additional challenges were present due to the location of the line, which was under water.

*The sand-blasted pipe surface shows corrosion defects.*

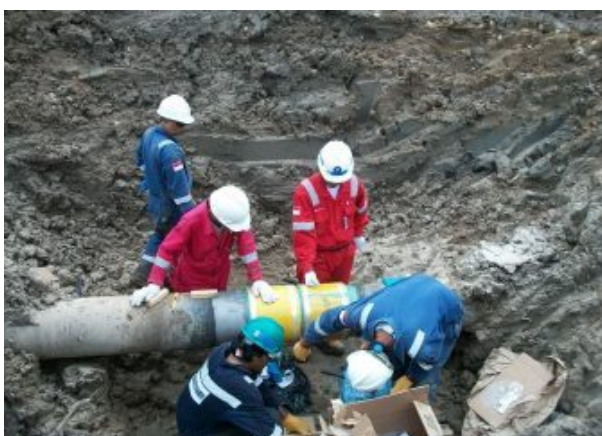
*Certified installers place bridge units on each side of the weld.*

A team of trained installers placed units on each side of the weld as a bridge, installing 8 Clock Spring repair sleeves in all and delivering a complete repair within 3 hours.

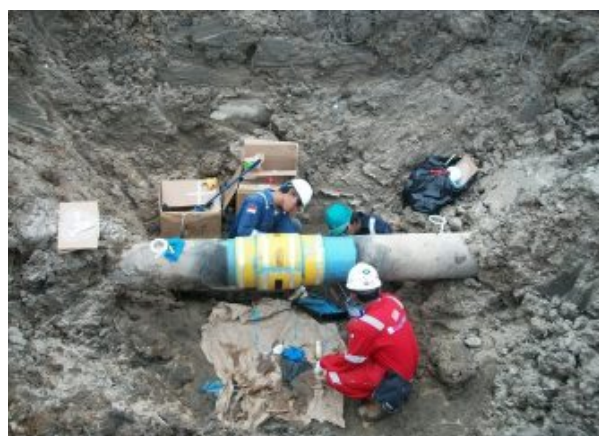
*The team completes the repair with the installation of the third coil.*
