# Composite Repairs with Embedded Thickness Monitoring Technology

### Summary

A European chemical manufacturer and producer of pharmaceutical-grade reagents experienced pipe erosion and corrosion, including an internal through-wall defect in a heat exchanger. The exchanger was an important part of an aging unit in a chemical plant that produces ethylene vinyl chloride. The unit was scheduled to be completely replaced in a major plant rebuild two years away. The asset owner not only required repairs that would mitigate the through-wall defect and restore the structural integrity of the pipe, but also required a means to monitor wall thickness of the pipe moving forward. The Inductosense thin, battery-free, ultrasonic thickness measurement (TM) sensor, combined with [ThermoWrap® MT](#), allowed the asset owner to assess conditions remotely, eliminating the costs of more complex in-person inspections. The ThermoWrap MT repair with the embedded sensor system made it possible to monitor conditions proactively and keep the heat exchanger in service until the required replacement date.

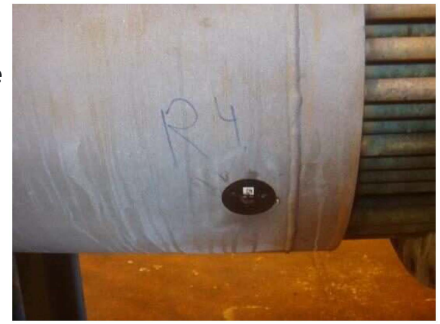
*Sensors were positioned seven inches inside the boundaries of the repair.*

Inductosense TM sensors were then embedded under the six-layer ThermoWrap MT repair. Due to the operating temperature of the heat exchanger being 80° C, a suitable high temperature adhesive was employed to permanently install the sensor. A total of eight Inductosense TM Sensors were positioned seven inches inside the boundaries of the repair area on both ends at the 12 o'clock, 3 o'clock, 6 o'clock, and 9 o'clock positions. Localised heating was used during the installation to heat up the installation area to the sensor adhesive curing temperature.

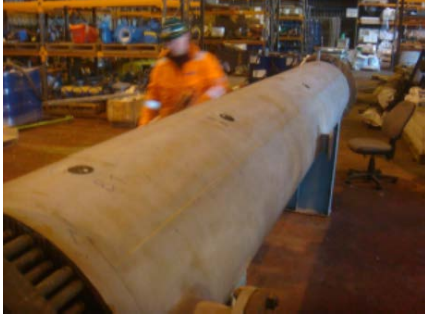
*Sensors were permanently installed with high temperature adhesive.*

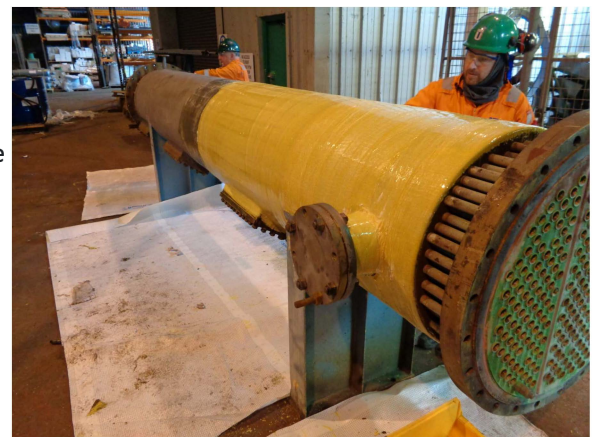
*With the WAND system, thickness measurement data can be accessed wirelessly through the ThermoWrap® MT repair.*

The structural integrity of the pipe was restored with the ThermoWrap MT composite repair. With sensors embedded under the ThermoWrap MT, the asset owner was able to collect and record data as often as desired with the use of the WAND hand-held data collector it to determine real-time wall thickness measurements. The WAND data collector devices (hand-held or remote) are able to connect with installed sensors to measure the wall thickness of the exchanger at any time for the life of the repair. This provides valuable information and an understanding of the continued fitness for service of the repaired area.

Managing the accumulated RFID-tagged measurement data with the iDART software, a corrosion rate can be determined from the historical measurements of the WAND system. This enables the end-user to plan better and operate infrastructure more efficiently, particularly for repaired components
