FORT MASON MUNICIPAL PIER STRENGTHENING

San Francisco, California

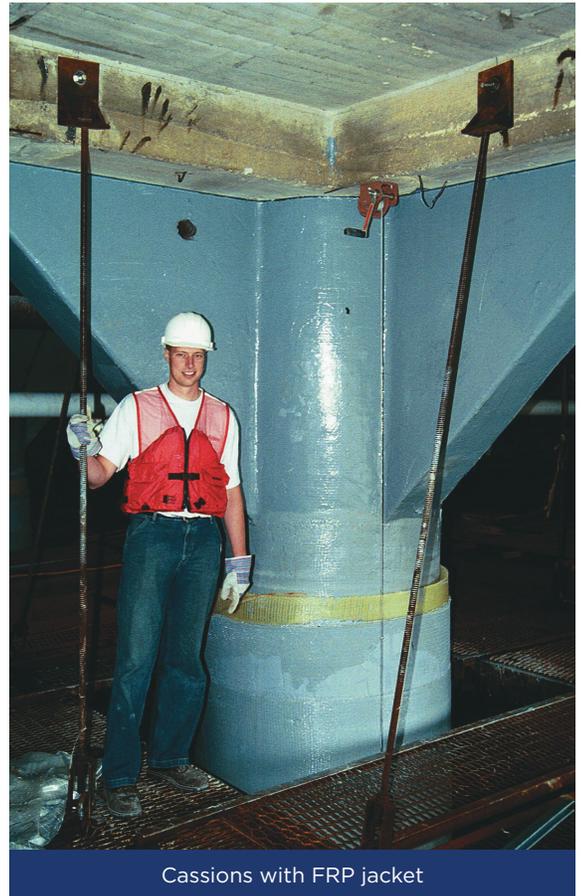
Cassions with FRP jacket

Fibrwrap Construction installed a prefabricated FRP jacket with a 2-inch angular gap around the cassions. Additional layers of wet lay-up FRP saturated in a water-curing epoxy, Tyfo® SW-1, were applied over the prefabricated jackets and then submerged in 4-foot tall sections until the cassions' entire 30-foot height was encapsulated by the jacket. The jackets were sealed at the bottom and the 2-inch angular gap was filled with non-shrink grout to provide contact between the FRP jacket and the new cassion cross section.
