# GROVE ISLE BRIDGE REHABILITATION

Location: Miami, FL

## OVERVIEW

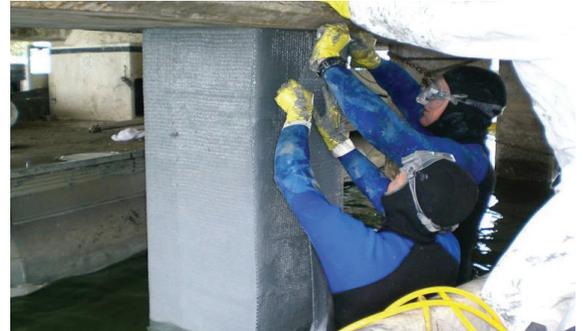
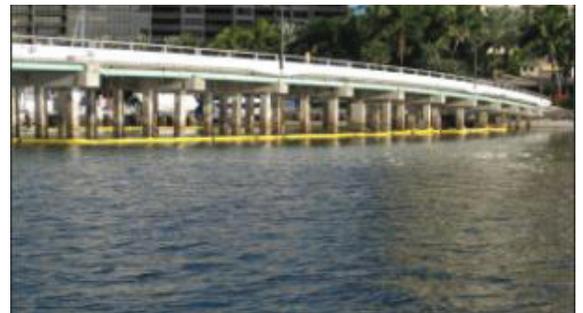
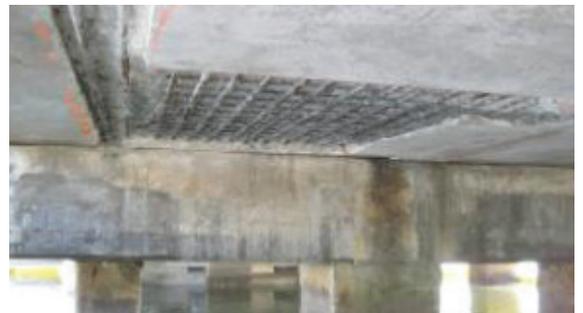
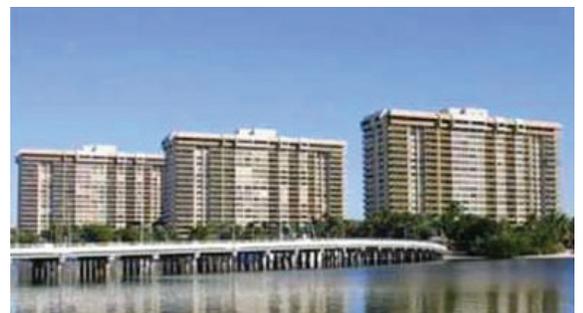
The approximately 800 foot long, privately owned concrete bridge connecting Miami and Grove Isle required extensive repair involving piles, caps and slab units as well as items above the bridge deck. The bulk of the repairs involved reinforcement treatment and concrete patching to the underside of the bridge deck slab units. In lieu of conventional hand-patching techniques at the underside of the concrete deck, a “form and pump” method was utilized. Additionally, due to the condition of the existing reinforcement, numerous deck spans required strengthening utilizing the Tyfo® SCH-41-2X System.

Many of the square concrete piles were repaired and wrapped with the Tyfo® SEH-51A System incorporating the underwater-curing Tyfo® SW-1 Epoxy. The piles were wrapped from the mud line to the deck and divers were required to install the system on 18 piles.

The project also involved crack injection, deck sealing, a new pavement approach, new lighting and barrier repair. The Grove Isle Bridge was repaired for approximately \$2.3 million within a project timeline of six months.
