# GEO SPRAY®

### CASE STUDY:

## Sanitary Sewer Rehabilitation Cincinnati, OH

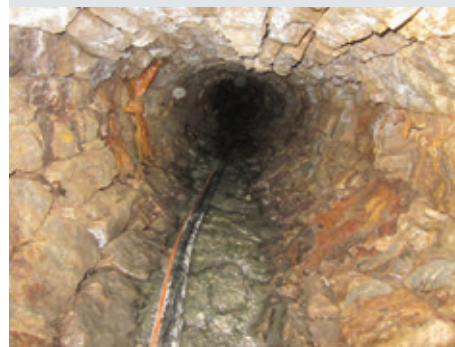
Corroded stacked stone sanitary sewer.

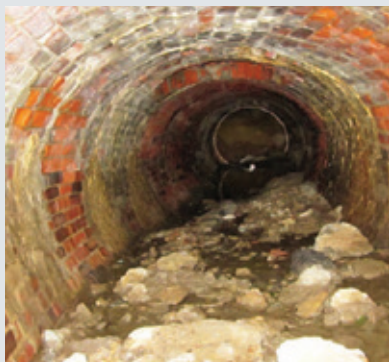
Large debris inside circular brick pipes.

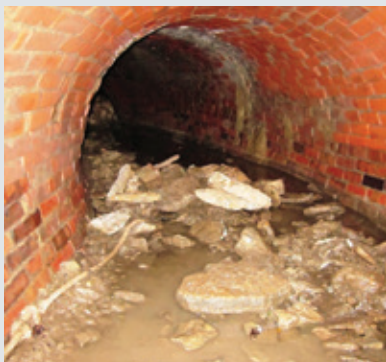
Significant curvature of existing structure.

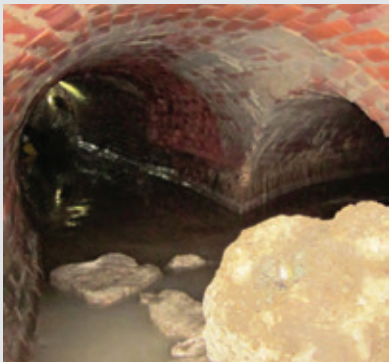
Pipeline diverging and changing sizes.

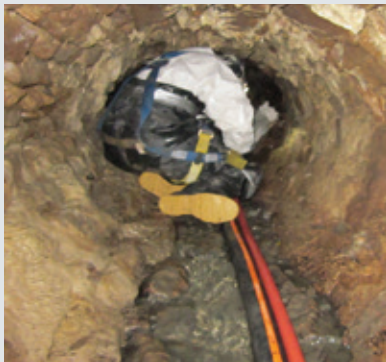
Hand-repairing of infiltration.

Construction on the site began in March 2012. The first task was to clean the stone pipe with a high pressure wash and then to use a hand-spray application of GeoSpray geopolymer to both stop the leaking and stabilize the existing stone structure.

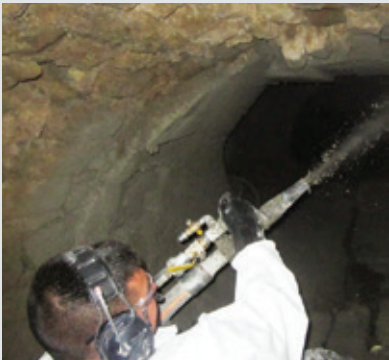
GeoSpray geopolymers being applied by hand spray to lock in existing brick and stone.

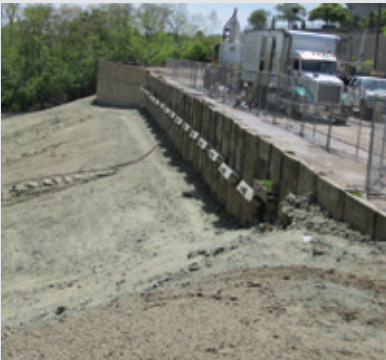
Extended working distance from material platform to repair site.

One critical advantage of centrifugally spraying a GeoSpray geopolymer liner is the equipment footprint can be limited to the size of approximately two 24-foot box trucks, and spraying can occur more than 200 feet from the actual mixing location. This allowed the crew to avoid causing any traffic disruption.

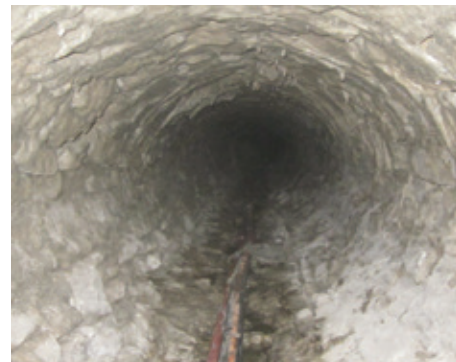
Stacked stone after reline.

Once the initial hand spray was complete, a mechanical sled system was used to apply the final coats and arrive at the engineer's required thickness, allowing for a new structural pipe to be built within the existing pipe.

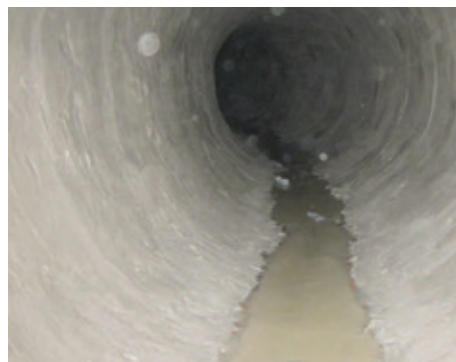
Circular brick pipe with curvature after completion.

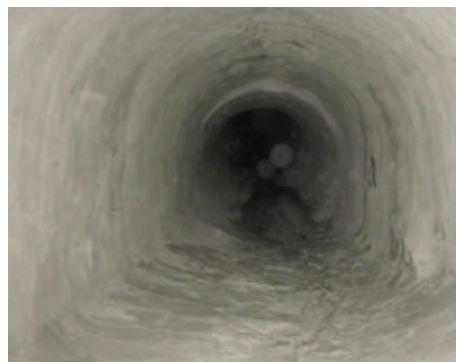
Arched brick pipe after completion.
