# MISSISSIPPI RIVER POWER CORPORATION PIPE REHAB

Location: Almonte, Ontario, Canada

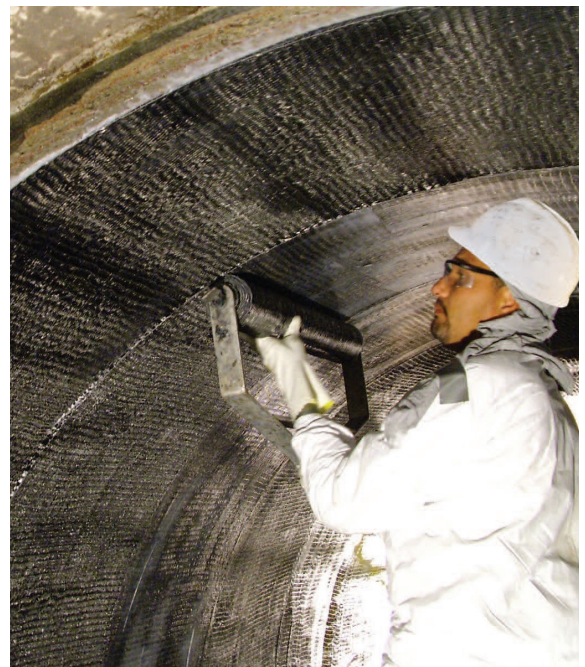
CFRP application to interior pipe

After a thorough technical review, the owner decided that using CFRP to line the interior of the designated pipeline segments was the most convenient and cost effective long-term strengthening option. Fibrwrap overcame significant leakage issues and installed a series of CFRP layers in the longitudinal and hoop direction to take the place of removed steel pipe. As an added precaution in the transition structure that had a unique geometry, the Tyfo® system was anchored into the concrete using carbon fiber anchors installed on a square grid. The repair provides a standalone, fully structural pipe enhancement.
