# A PERMANENT SOLUTION

**MATT BOUCHER, CLOCK SPRING, USA, DETAILS A SOLUTION FOR PIPELINE PROTECTION AT SUPPORT AND HANGER LOCATIONS, WHICH CAN PREVENT PIPELINE CORROSION AND REDUCE INSPECTION COSTS.**

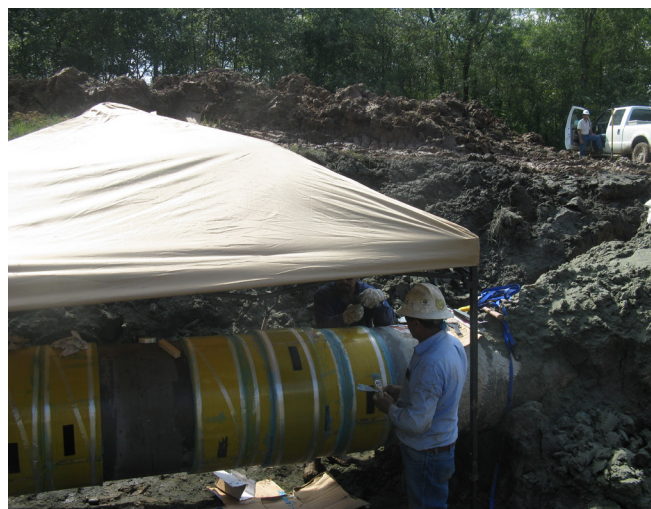
Figure 1. Workers installing Clock Spring's Pipe Support.

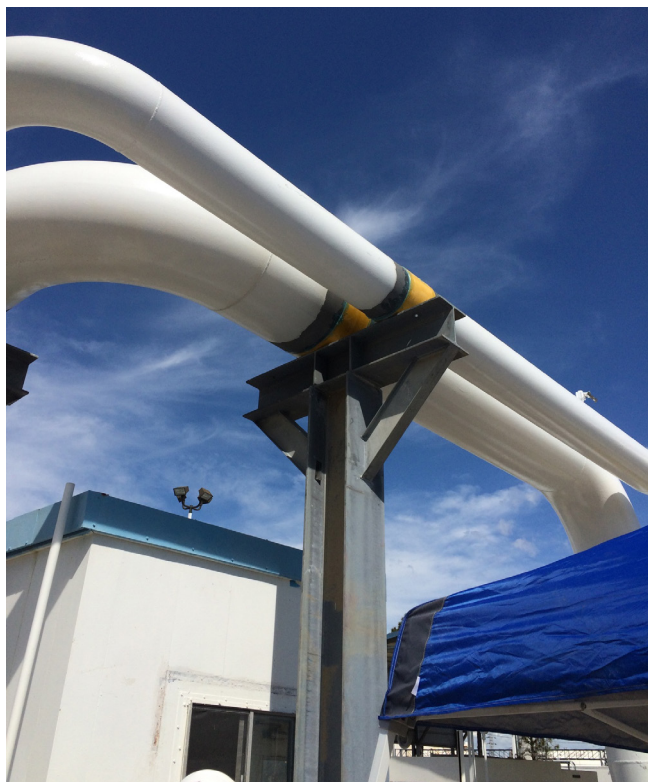
**Figure 2.** Clock Spring's Pipe Support applied to a liquid pipeline.

Clock Spring Pipe Support was applied to a liquid pipeline in Pasadena, Texas (USA).

Figure 2 is an example of an elevated pipe. The height of the pipe limits access to heavy equipment, causing the operator to select the Clock Spring pipe support system.

The continuous wrap protects the full circumference of the pipe. This sleeve, which is actually a series of split sleeves, is easy to install in tight spaces and limited clearance areas. In this particular case, installation was only 1 - 2 in. of clearance and done from a manlift.

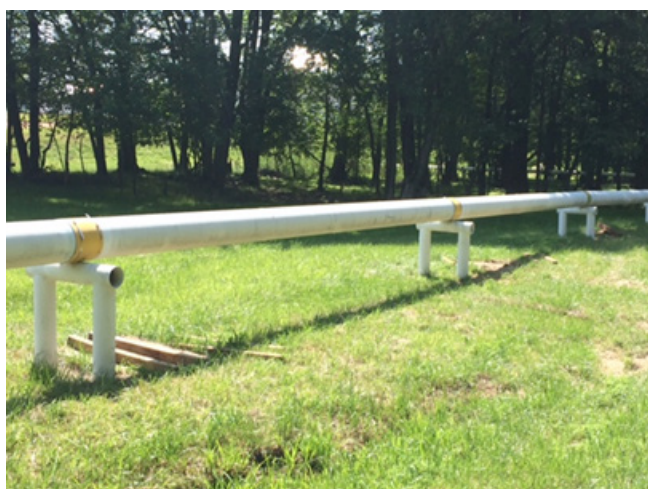
**Figure 3.** Clock Spring's Pipe Support applied to refined product pipe.

Clock Spring Pipe Support was applied to a refined product pipe at a tank farm in Pennsylvania (USA).

Figure 3 is an example of a 12 in. refined product pipe.

Prior to installation of the pipe support system, the pipe was jacked, blocked and sanded with a mechanical grinder. Implementing a pipe support system as a preventive measure elevates the integrity of the pipe and reduces the risk of the operator having to interfere with production due to corrosion at support locations.
