COMPOSITE SOLUTION RESTORES ERODED PETROCHEMICAL PLANT LINE

BY ANDREW PATRICK

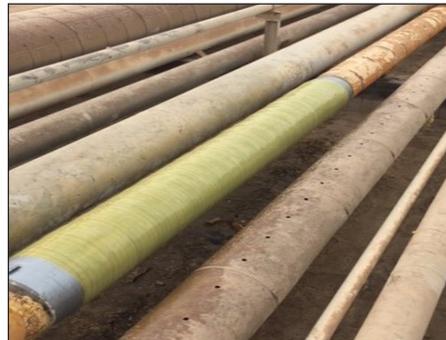
Working in tight quarters, installers applied the Contour engineered composite repair by hand, installing a safe and reliable permanent solution in two weeks and restoring the line to safety without having to interrupt operations.

Applying the quad-axial stitched fiberglass cloth by hand, the team covered the damaged areas with

eight layers of the ECR. The entire repair was completed over the course of two weeks, restoring the line to safety without interrupting operations and delivering a safe and reliable permanent solution within a demanding project schedule.
