TYFO® FIBER REINFORCED POLYMER COMPOSITES USED FOR SHEAR WALL STRENGTHENING

360 Spear Project in San Francisco, California

PROJECT PROFILE: STRUCTURAL STRENGTHENING TYFO® SYSTEM

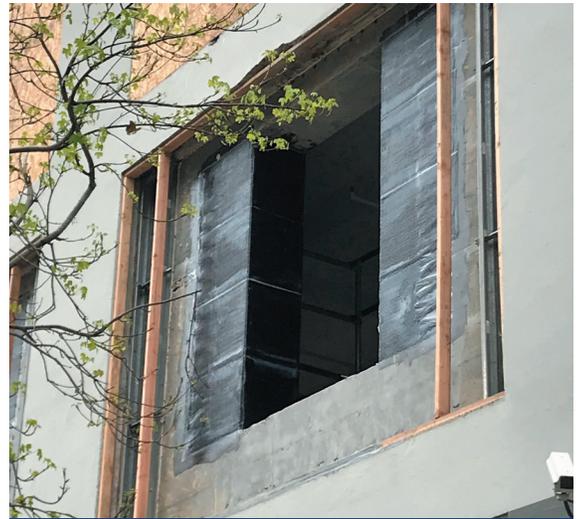
Exterior application

Fyfe was contacted to develop a fiber reinforced polymer (FRP) composite design for additional confinement to the boundary bars and existing reinforcement around the new openings in the shear walls. Tyfo® SCH-41 fiber was used to confine the existing reinforcement and Tyfo® SCH composite anchors were used to fully develop the fiber capacity. Several columns were also strengthened with the Tyfo® SCH-41 system to provide additional axial capacity. A Tyfo Certified Applicator, was contracted by Fisher Inc., the general contractor, to perform the installation of the fiber system. FRP strengthening was used instead of steel members because it could easily be hidden from view while still achieving the design goal.

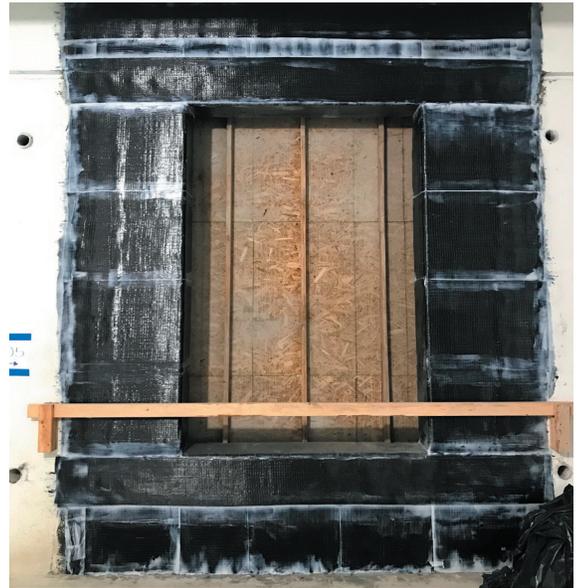
Four sided interior application

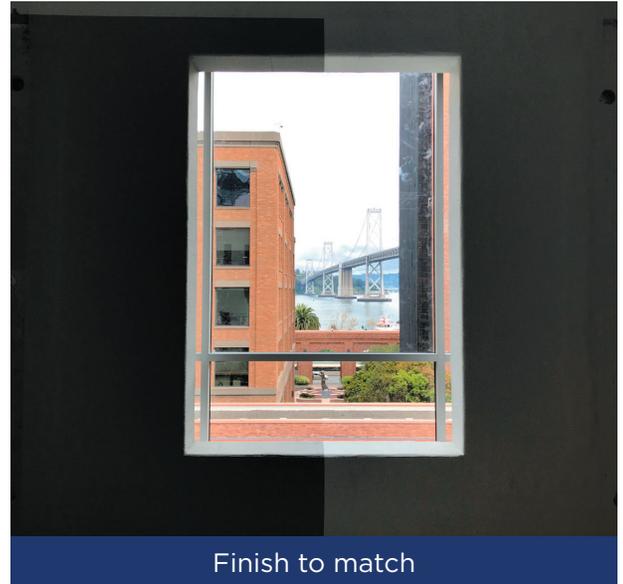
Finish to match

The fiber allowed the shear walls to be strengthened while also accommodating existing finishes. On the exterior facade, a cement plaster was used to match and hide the areas receiving FRP. The FRP on the interior was painted to match. This would not have been possible if a steel or concrete alternative had been used.

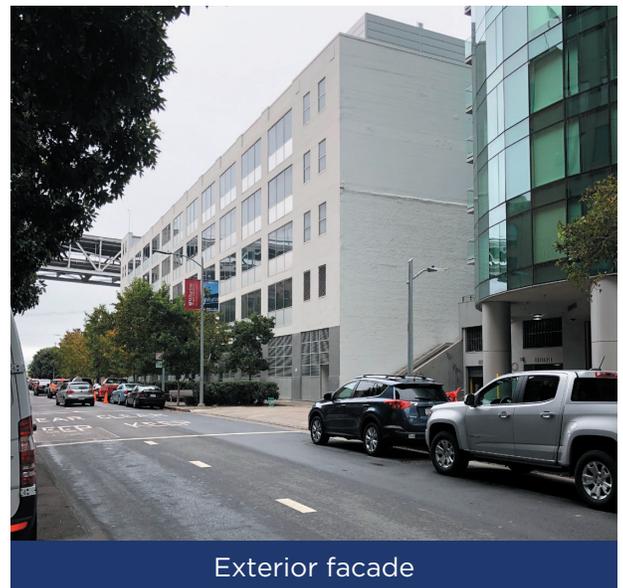
Exterior facade
