**PROJECT PROFILE:  
BRIDGE REHABILITATION LOCTITE FRP SYSTEM**

# GROVE ISLE BRIDGE REHABILITATION

Location: Miami, FL

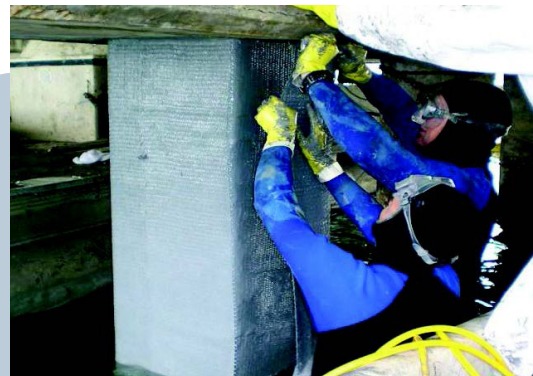
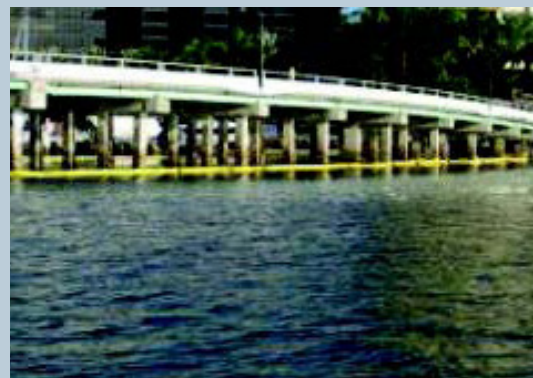
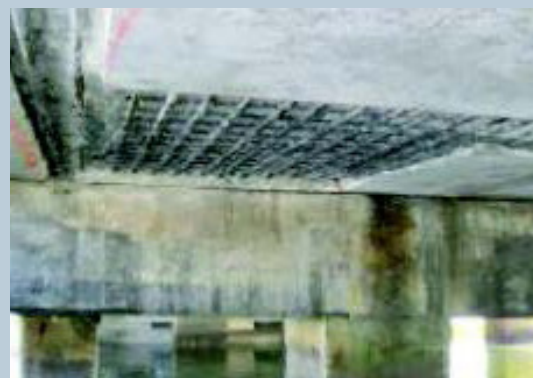
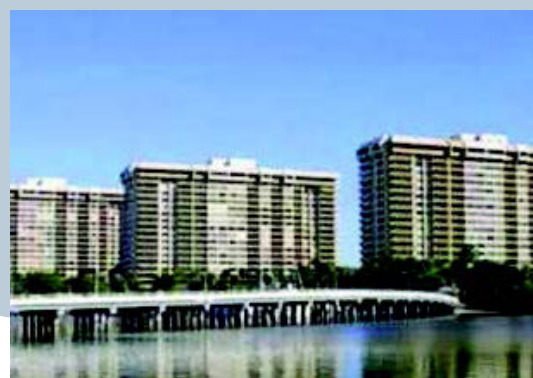
The approximately 800 foot long, privately owned concrete bridge connecting Miami and Grove Isle required extensive repair involving piles, caps and slab units as well as items above the bridge deck. The bulk of the repairs involved reinforcement treatment and concrete patching to the underside of the bridge deck slab units. In lieu of conventional hand-patching techniques at the underside of the concrete deck, a “form and pump” method was utilized. Additionally, due to the condition of the existing reinforcement, numerous deck spans required strengthening utilizing the LOCTITE SCH-41-2X System.

Many of the square concrete piles were repaired and wrapped with the LOCTITE SEH-51A System incorporating the underwater-curing LOCTITE SW-1 Epoxy. The piles were wrapped from the mud line to the deck and divers were required to install the system on 18 piles.

The project also involved crack injection, deck sealing, a new pavement approach, new lighting and barrier repair. The Grove Isle Bridge was repaired for approximately \$2.3 million within a project timeline of six months.
