# PROJECT PROFILE: PIPE REHABILITATION LOCTITE TYFO SYSTEM NUCLEAR POWER PLANT PIPE REHABILITATION

LOCATION: NORTH CAROLINA, UNITED STATES

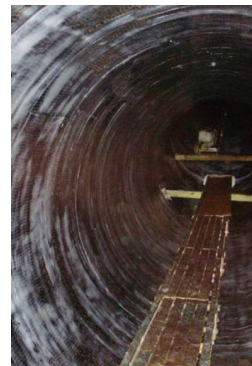
LOCTITE TYFO  
application

The scope of work included removal of the cement mortar liner so that the fiber wrap could achieve a structural bond with the steel substrate. Also, chlorides were removed from the steel pipe walls by means of blasting, and chemical treatment prior to bonding. Finally, the LOCTITE TYFO systems were applied in the longitudinal and hoop direction, as dictated by the structural design which was completed using finite element analysis. The fiber wrap design was standalone throughout the straight pipe segments and designed as a composite section at the bends and at the supports; this allowed for the remaining steel section to provide the stiffness required in resisting thrust forces at those locations. Once the fiber installation was completed, compression rings were applied at the fiber terminations for improved detailing and to prevent shear slipping due to longitudinal forces.

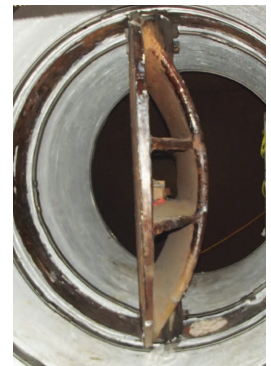
Steel substrate prepped  
for application
