# GEOSPRAY® 61

Geopolymer Mortar

## Minimize Impact to Wildlife and Water Quality During a Creek Culvert Rehabilitation

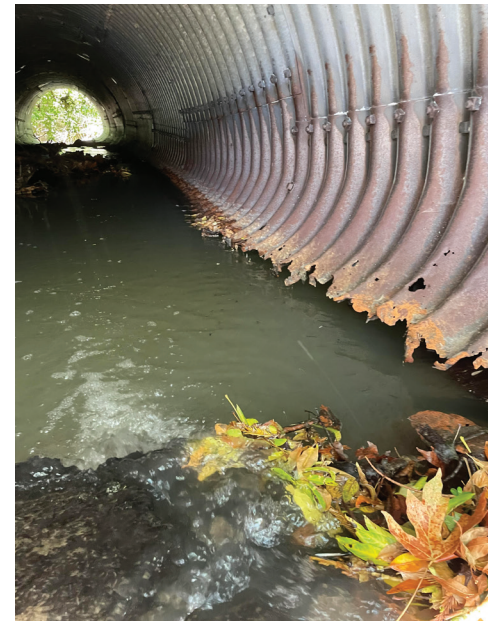
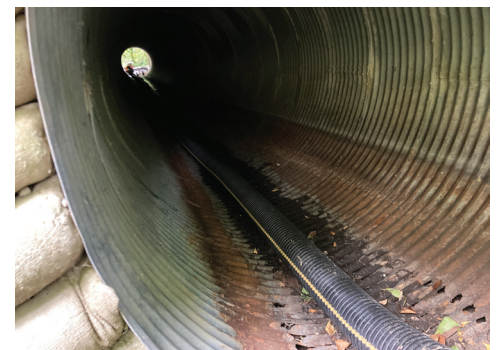
*Bypass through culvert to be rehabilitated*

In preparation for the rehabilitation work, a diversion was put in place which would run the summer creek flow through a gravity flow bypass pipe without the use of a pumping system, which could negatively affect aquatic life. The additional benefits of the gravity flow bypass were that it did not change the flow of the creek up and down stream during the rehabilitation, did not increase turbidity (NTUs) or increase erosion from the discharge of the bypass pipe. The bypass was installed directly through the pipe being rehabilitated which allowed for the gravity flow to occur. This was suggested by GeoTree Solutions as the chemical nature of GeoSpray allows for chemical bonding across the interface - even with pours 28 days apart - resulting in a monolithic structure that other geopolymers and mortars are not able to obtain. The city hired LSA from Point Richmond, California to have a wildlife biologist on site to verify that the bypass and the installation of the GeoSpray 61 was not affecting wildlife.

National Plant Service Manager Danial Solano said “A temporary dam was installed using gravel filled geotextile bags and plastic. This directed the water from the upstream side of the culvert into the bypass pipe. The bypass pipe exited the culvert and drained into the creek downstream.” The project consisted of three culverts at different locations within City of Orinda that each sat on different tributaries. One was a 72 inch by 110 inch acm arch culvert, the other two were cmp culverts measuring 66 inch and 60 inch. All mixing and pumping operations were carried out on a spill control pad within a tarp tent to minimize dust release. A disposal container sat next to the mixing area for the cleaning the hoses that conveyed the material into the culvert to the spray head applying the material.

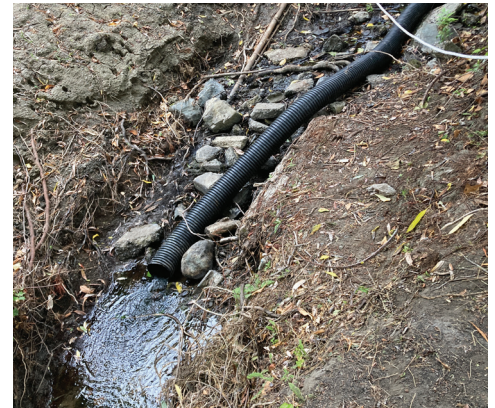
Discharge of bypass outside culvert

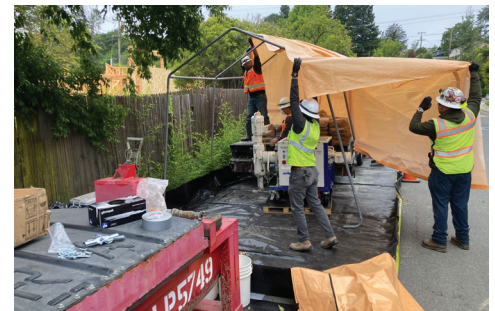
Construction equipment either on side of street or on residence driveway (footprint of 12 by 60 ft)

The construction equipment, which measured 10ft by 75ft, was staged along the street to ensure it did not affect traffic flow. For the arch culvert the equipment was along the side of a residence driveway (8ft x 35 ft) but access was still possible. Work could be carried out between 8:00 am and 4 pm to eliminate disruption to the residences. Each culvert from mobilization to completion took just five days.
