# FLORIDA CITY REHABILITATES MORE THAN 1,600 MANHOLES

## SCOPE OF WORK:

- 1,600 manholes rehabilitated
- 6,900 vertical feet restored
- Approximately 80,000 square feet of LOCTITE GeoSpray geopolymer lining installed

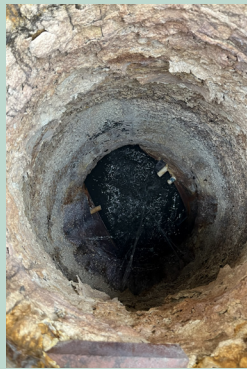
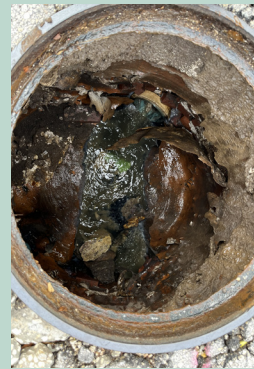
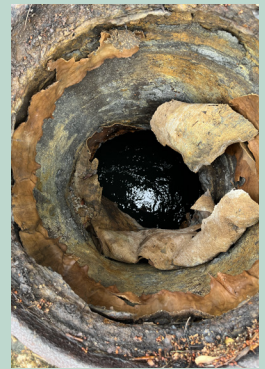
Severely deteriorated manholes

Between 2022 and 2025, a Florida water and sewer department undertook one of the largest manhole rehabilitation programs in the region to address extensive deterioration within its wastewater collection system. The work was carried out by a certified LOCTITE GeoSpray installer, using GeoTree's LOCTITE GeoSpray and LOCTITE GeoSpray HCE geopolymer spray-applied lining system. Over a three year period more than 1,600 manholes, that had been affected by decades of microbial induced corrosion (MIC), were rehabilitated restoring critical infrastructure.

Some of these severely deteriorated manholes required the use of injection grouting and also using GeoSpray HCE as the build out mortar to plug holes, fill gaps to stop groundwater infiltration and generally structurally stabilize and build back the original structure. As an added measure of protection, the completed GeoSpray HCE lining was coated with an additional layer of corrosion-resistant Neopoxy NPR-5305 Epoxy after the geopolymer had cured. This additional protective coating was applied to enhance durability and extend service life in these particularly aggressive environments.

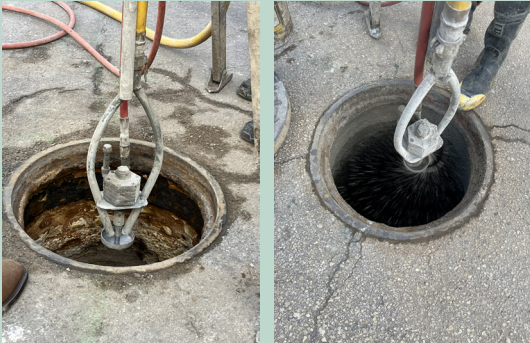
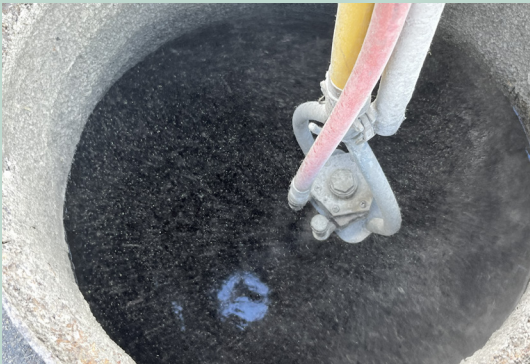
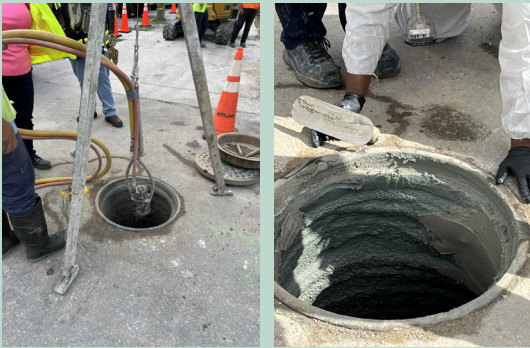
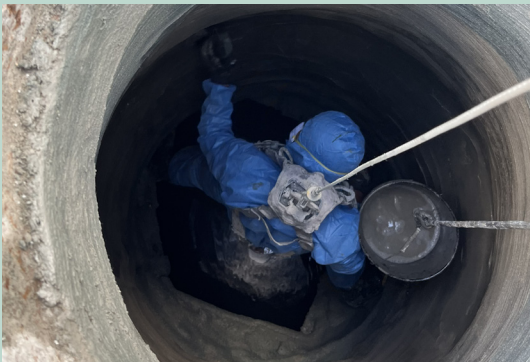
Installation in progress

Although the overall program involved more than 1,600 manholes, each structure was rehabilitated individually. Depending on the depth and severity of deterioration, complete rehabilitation of a single manhole, including cleaning, surface preparation, and lining installation, typically required only three to six hours.

Nighttime installation was frequently employed to reduce traffic impacts and maintain access along key transportation routes. Among the 1,600 rehabilitated structures, approximately 15 manholes were identified as critical special cases due to exceptionally severe MIC deterioration.

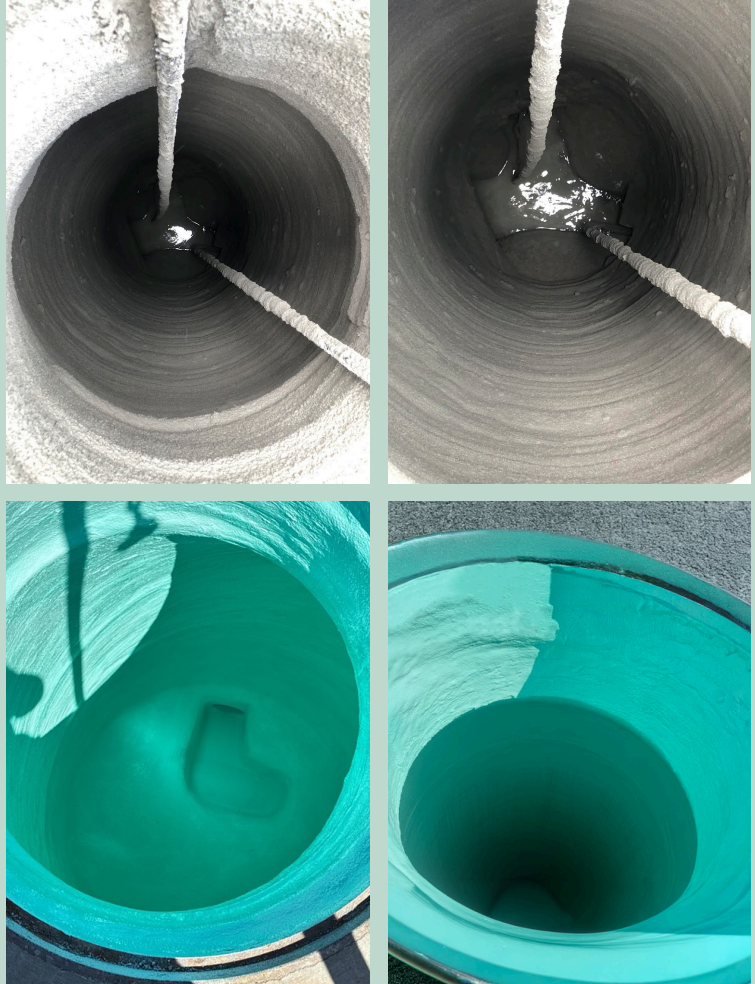
Completed installation

The program successfully restored more than 1,600 deteriorated manholes across the region's wastewater network, providing a long-term rehabilitation solution.
