DiamondWrap® HTA™ 12" – 42" Flare Line Repair in Bahrain

Pipe Details

Customer: Crude Oil Refinery

Location: Bahrain

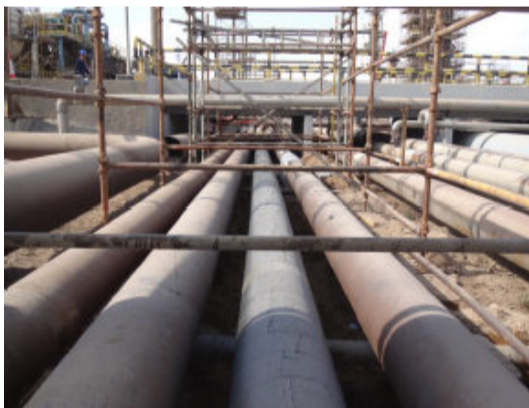
A team of trained and certified installers installed 2 layers of carbon fiber over the specified repair area, according to the calculations prepared by the Citadel Technologies engineer. Here is a chart of the repair lengths that were achieved on each diameter of pipe within the system.

Diameter	Total Repair Length
12" LPG	350 ft
12" 2 Poly	300 ft
24" GCU	100 ft
36" RHL	20 ft
42" FCCU	125 ft

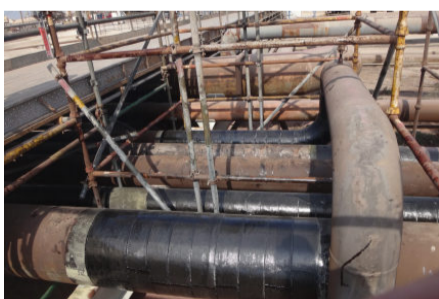
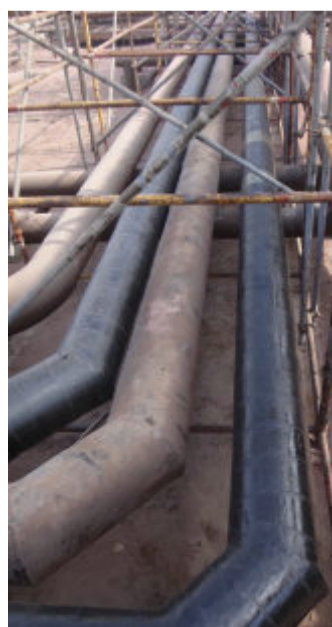
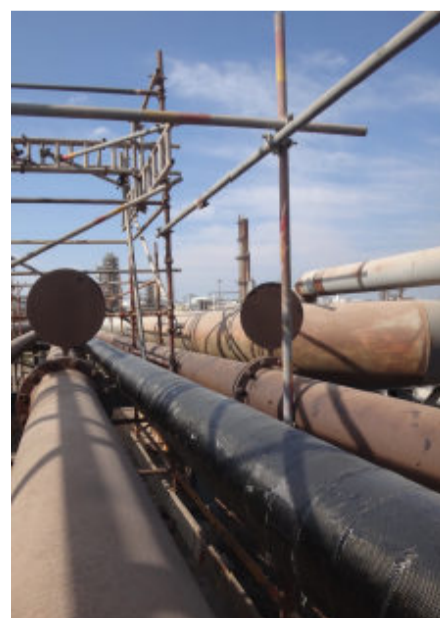
Pipe Defect: Internal Corrosion with 50% Wall Loss for long lengths of pipe

Below are photos of the completed repairs:

Citadel Technologies' team of engineers designed repairs for each diameter and repair length according to ASME PCC-2 Article 4.1, and recommended a DiamondWrap® HTA™ repair solution to the refinery. Only 2 layers of DiamondWrap® were required to repair the internal thinning at the given pressures. Repairs were designed for tees, straight runs, elbows, and reducers. Many of these geometries would be prohibitive of using clamps.
