DiamondWrap® HTA™ 80" MDEA Pressure Vessel in USA

Customer: Large Ammonia Plant in US

Vessel Defect: Severe internal corrosion

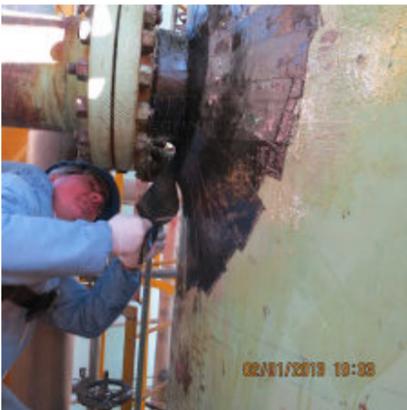
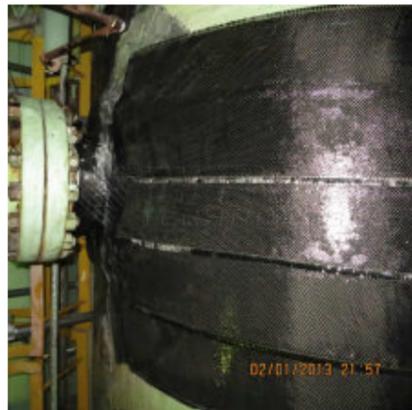
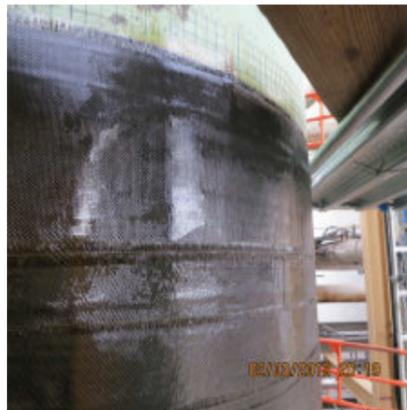
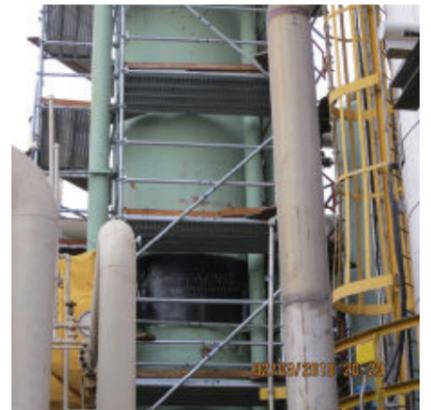
A team of trained and certified installers installed 4 layers of carbon fiber over the specified repair area, according to the calculations prepared by the Citadel Technologies engineer. The installation was implemented while the plant was in service, with no need for costly shutdown or reduction in capacity. Below are photos of the completed repair:

Citadel Technologies' team of engineers designed repairs for each defect according to ASME PCC-2 Article 4.1, and recommended a DiamondWrap® HTA™ repair solution to the plant. Only 4 layers of DiamondWrap® were required to repair the defect at the given pressures. The design called for the repair to extend the entire length of the effected shell course.
