# GEOSPRAY®

## Used to Line Corroded Culvert

Washington Street

Culvert Rehabilitation

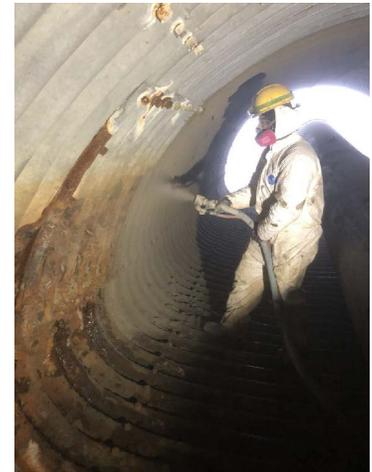
GeoSpray applied to the walls of the culvert.

Approximately 2.75" of GeoSpray mortar was applied to the interior walls of the 96' long, 11' 7" wide and 7' 5" high metal arch culvert.

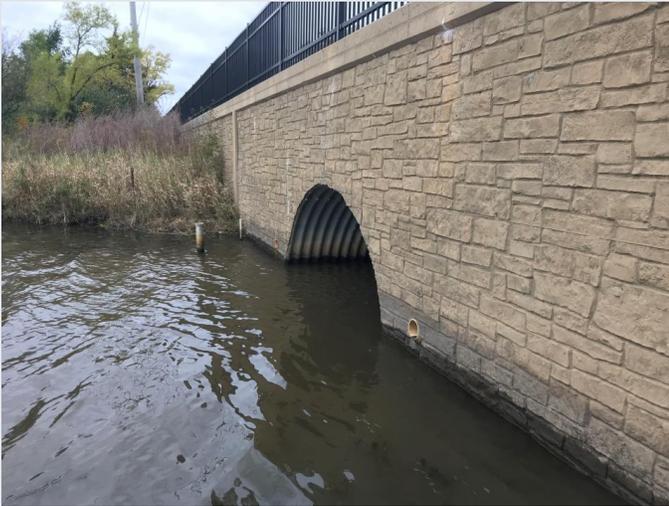
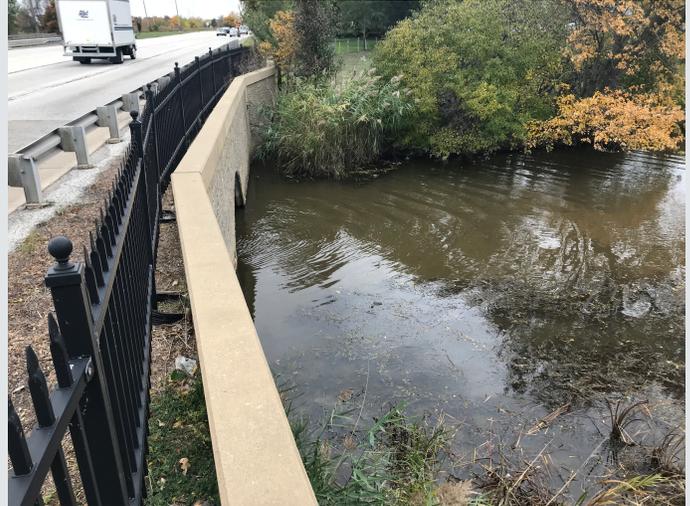
1 Culvert inlet and outlet before repair.

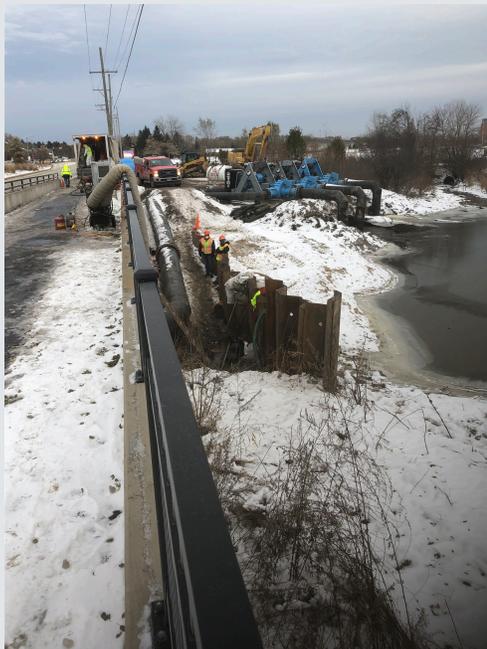
2 Cofferdam and draw down pumps put in place.

The culvert was in place to drain the upstream Mill Creek watershed under Washington Street near Grayslake, Illinois. In order to carry out the lining work with no internal flow during the installation, a 36" HDPE bypass pipe was placed on 12" blocks and run through the culvert. The bypass system included pumps and a cofferdam installed at the culverts inlet to divert flow through the internal bypass pipe during the hand spraying lining operation. This enabled the installation team to spray line the pipe without disrupting the flow of Mill Creek. The 36" bypass pipe was removed at the completion of the lining and after the area under the elevated bypass pipe was sprayed.

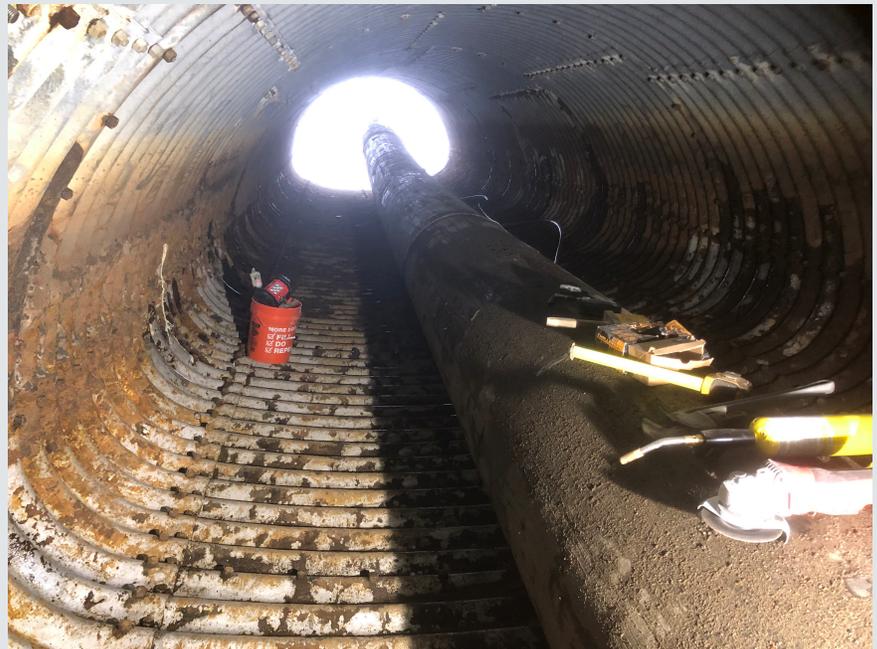
3 Bypass HDPE pipe laid through culvert.

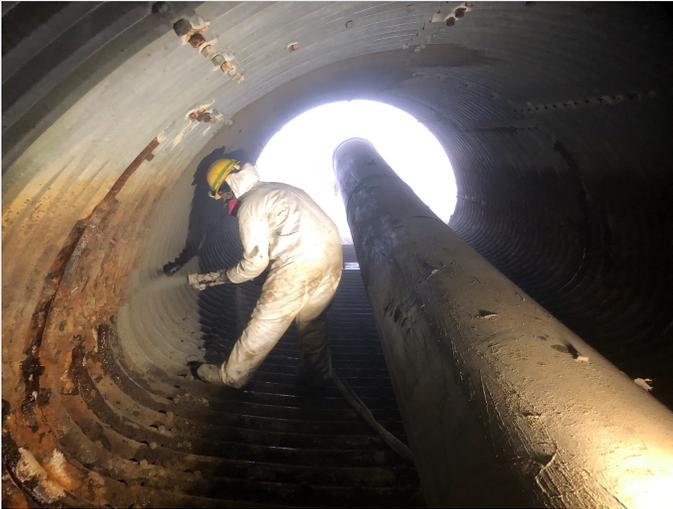
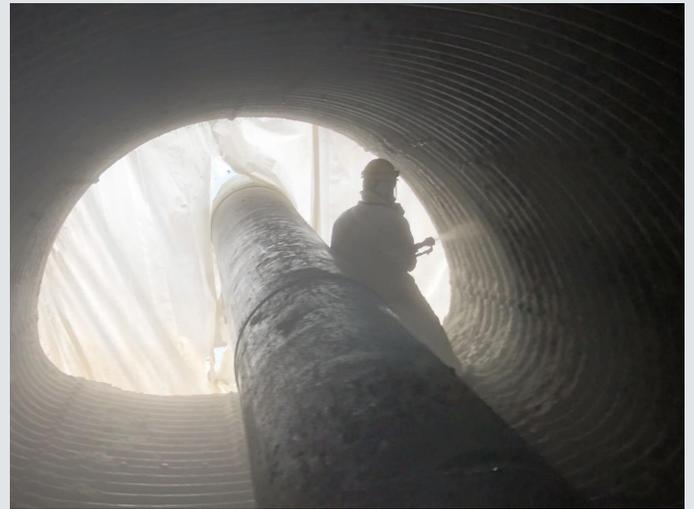
4 GeoSpray applied to the walls of the culvert.

Due to the extreme cold conditions, Michels tented the culvert ends and applied internal heat to the inside of the pipe during the operation to ensure the product could be applied and cured correctly. The use of specialized grouts was required to seal any active infiltration from joints and, rusted through voids/holes, found within the culvert length. Applied in layers, the Michels team took five days to complete the geopolymer lining installation once the bypass system was placed.

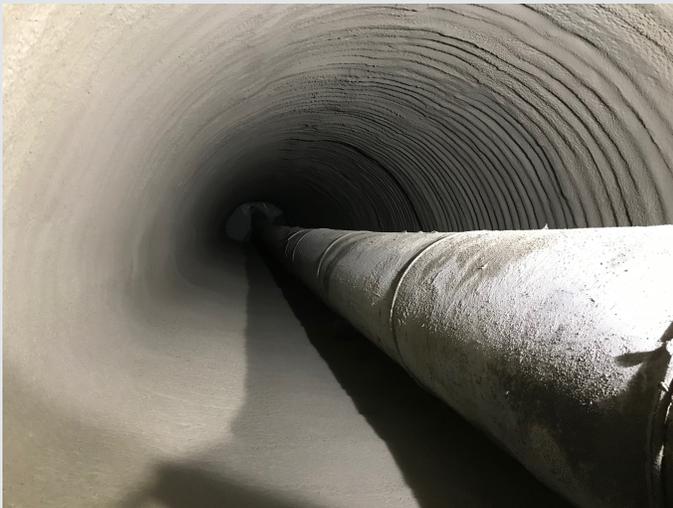
5 Completed install of GeoSpray.

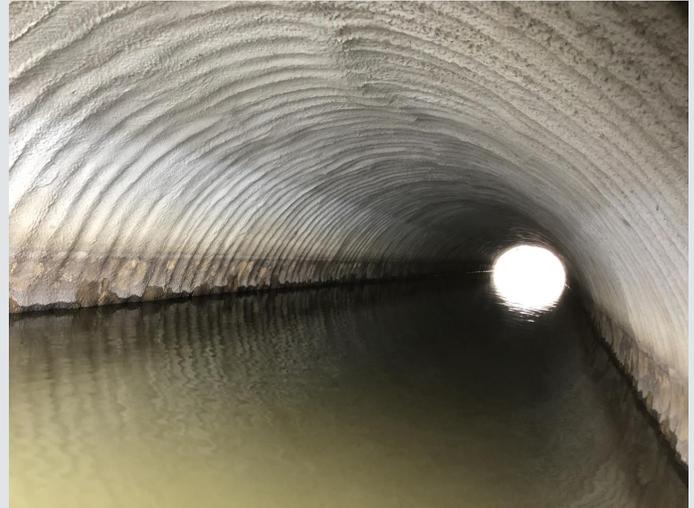
6 13 months after installation, GeoSpray lining remains strong and secure.
