RENEWWRAP®

CASE STUDY:

St Bernard
Parish, Louisiana

Application: Bridge Slab Strengthening

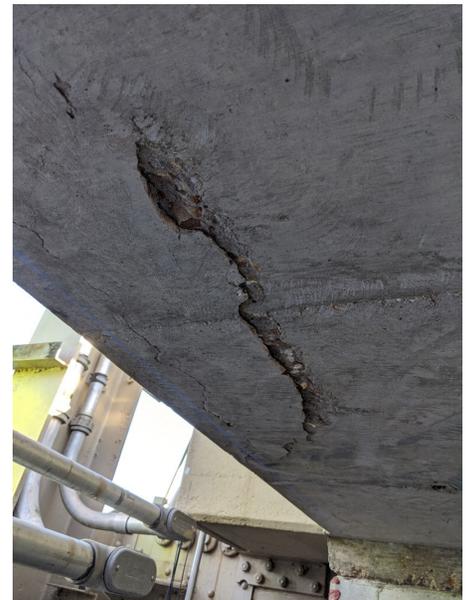
Severe spalling to the underside of the bridge

A 4-person installation team from Durable Piling Restoration was deployed to the site, and the application was observed by two LADOT representatives and one GeoTree product specialist. Taking three days to complete the work, the longest part of the repair involved the removal of spalling concrete. The largest area of spalling was of a 2ft by 2ft section of concrete which was crumbling and falling away. This portion was chipped away until all loose concrete was removed, a repair mortar was then used to patch the resulting hole.

Bugholes in the concrete were repaired with GeoTree's EZ Paste repair putty and the RenewWrap material was then installed over this repair covering 18, 16ft-long spans using RenewWrap CF335 1x24". Due to the large section being repaired, a dry lay-up technique was used. This involved a layer of resin being applied to the substrate at all locations where fabric was going to be installed. After approximately 15 minutes, once the resin was tacky, the dry fabric was rolled out onto the resin with a further layer of resin then coated onto the hung fabric.

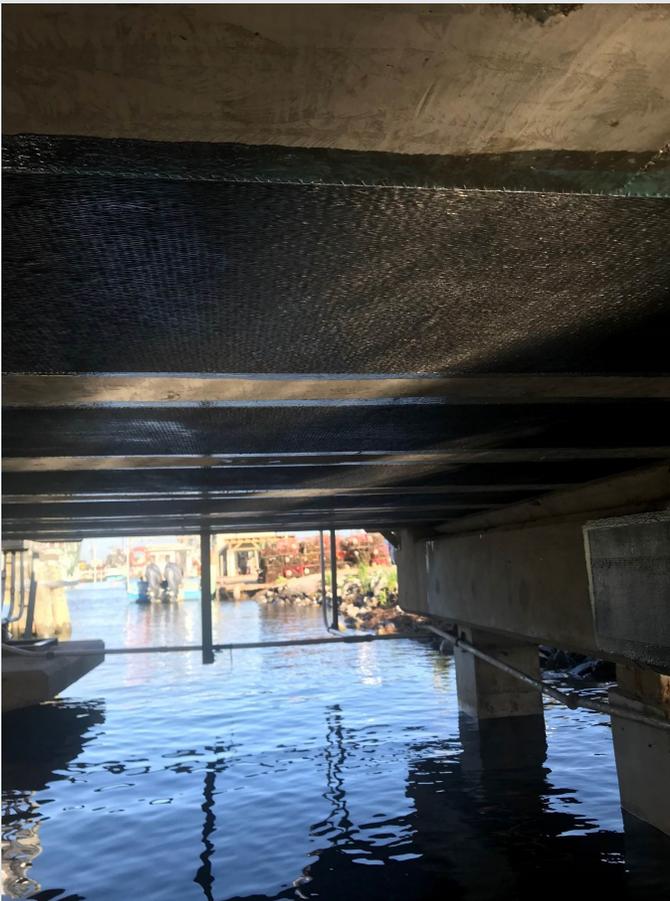
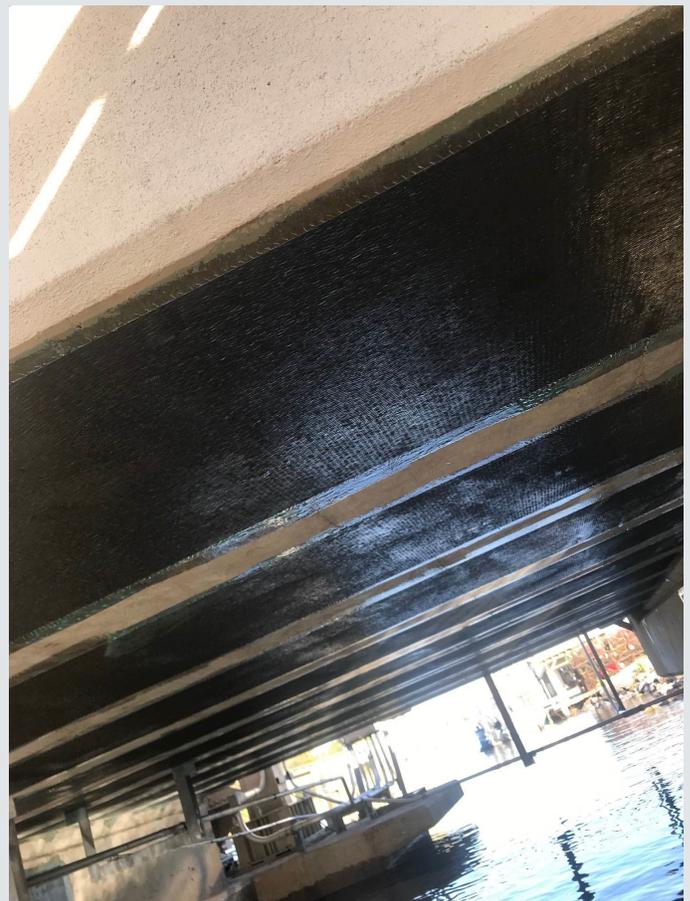
Completed RenewWrap CFRP install
