PROJECT OVERVIEW

As part of the 13 Mile Road rehabilitation from Haggerty Road to Halsted Road, twin parallel 78" CMP culverts were to be relined with geopolymer mortar. Each of the twin culverts are approximately 200 linear feet. The culverts are used carry the flow of Seeley Drain under 13 Mile Road immediately east of Haggerty Road.

CASE STUDY: Farmington Hills, MI Culvert Rehabilitation

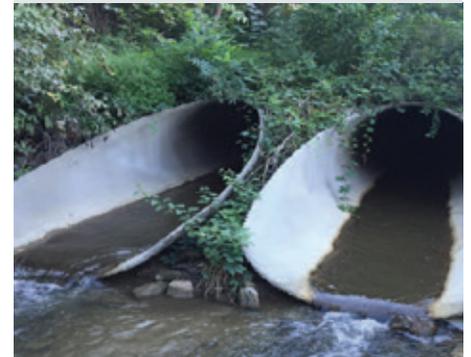
Twin culverts in use after GeoSpray mortar rehabilitation.

The twin culverts were successfully relined and replaced into full service within ten working days. The engineering design called for a minimum of 1.5 inches of GeoSpray to be used as the lining based on the physical properties of the geopolymer and the site load conditions. Personnel from the MDOT Bridge Office inspected the lining process and the final culvert repair.

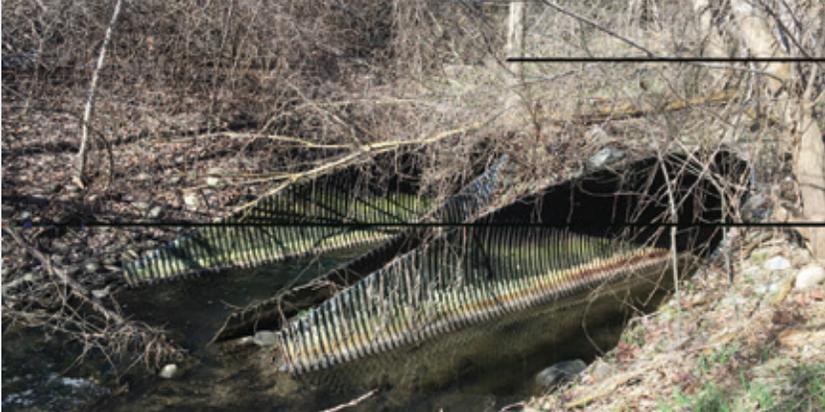
The design consultant, HRC, evaluated and selected a geopolymer lining solution after evaluating other rehabilitation options. The CMP culverts were experiencing moderate to severe deterioration with a 95% loss of steel in some sections. A benefit of the site was the twin culverts allowed for diversion pumping of the active flowing Seeley Drain so that one pipe could be repaired while the other was used for complete flow diversion. GeoSpray geopolymer mortar was the selected material for repair. The geopolymer mortar was hand-sprayed by Inland Pipe Rehabilitation in Detroit working as a subcontractor to Dan's Excavating. An advantage of the GeoSpray system is the flexibility in application, which allows the contractor to optimize the process to meet client expectations. Centrifugally casting, hand spraying, troweling and pouring are all options. In this project, hand spraying was chosen by the contractor to improve efficiency of the daily work based on site conditions and access.

Deteriorating existing culverts.

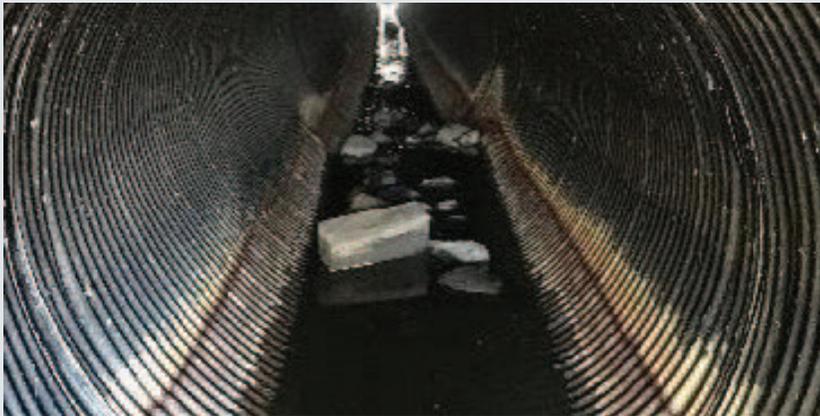
Debris and deterioration within culvert.

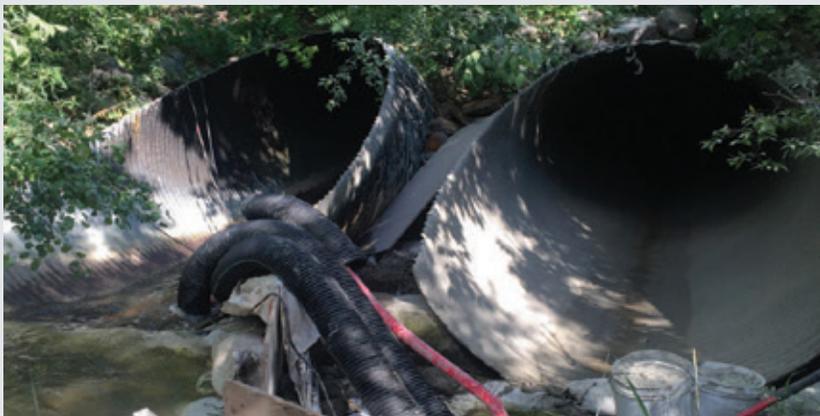
Installation of diversion pumping system.

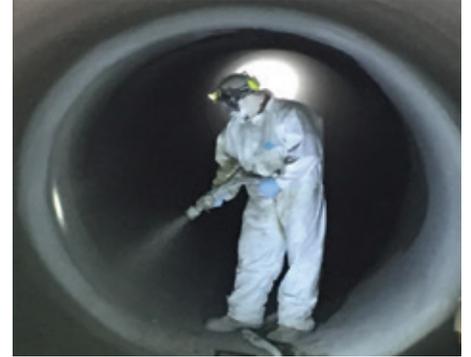
Hand spraying placement of geopolymer lining.

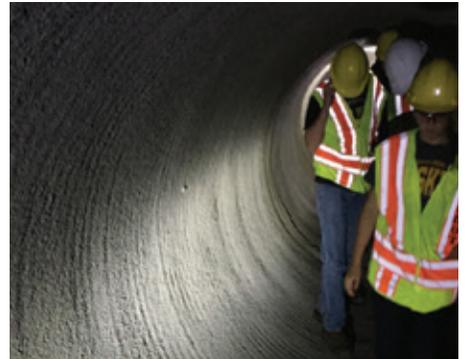
Inspection of lining by MDOT bridge personnel.

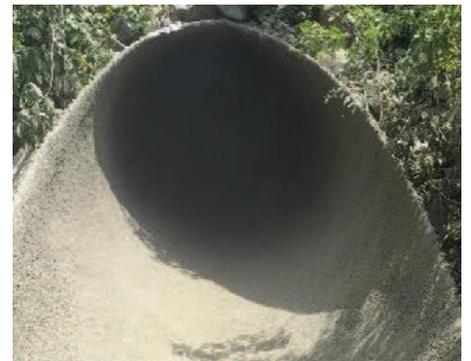
Completed geopolymer lining.
